Grant deed

[Wielangta Road upgrades]

Wielangta Road

Assessment of roadwork requirements

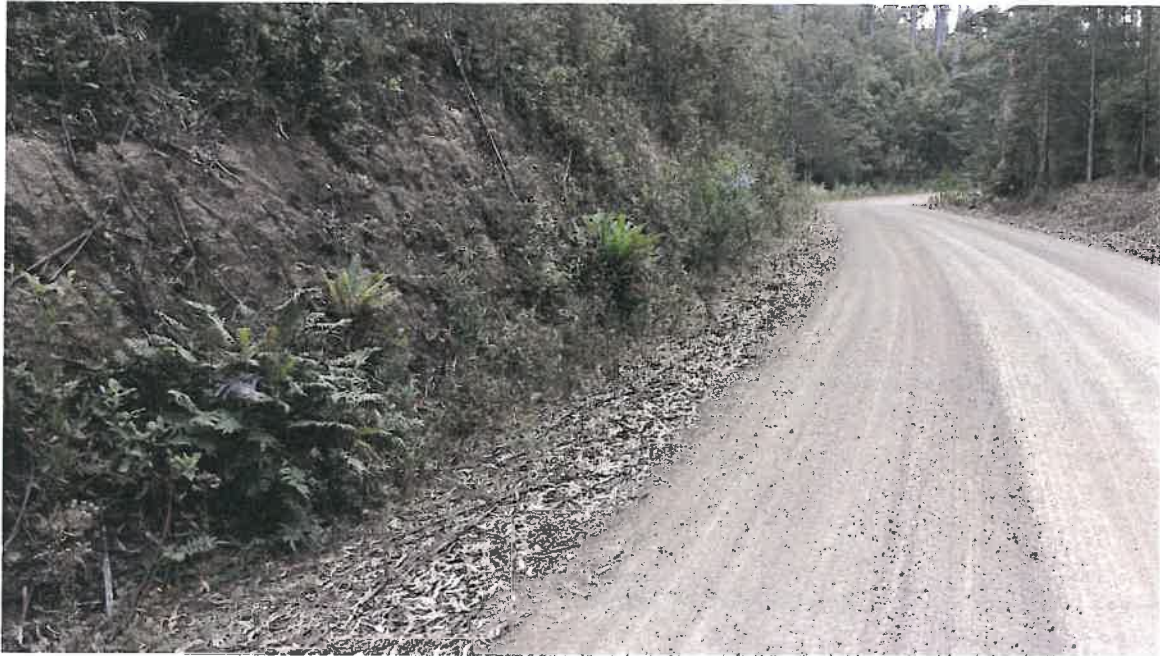
At locations where road surface conditions were found to be 'better' than typical, a reduced thickness requirement of 75mm has been adopted. For locations found to be in a 'worse' condition than typical, an increased thickness of 150mm has been adopted.

Figure 2 – Road surface rated as requiring reduced overlay thickness of 75mm

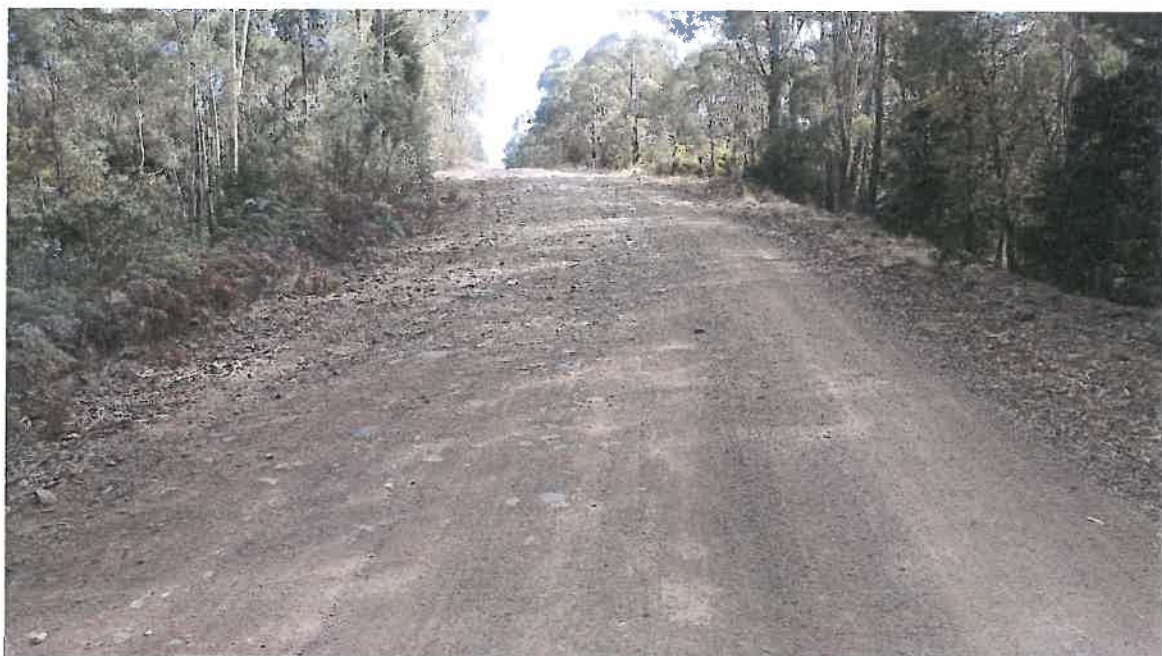
Gravel overlay thickness requirements have been based on the assumption that in general, the pavement will receive a nominal 100mm compacted layer of suitable quality gravel.

Figure 3 – Road surface rated as requiring 100mm overlay

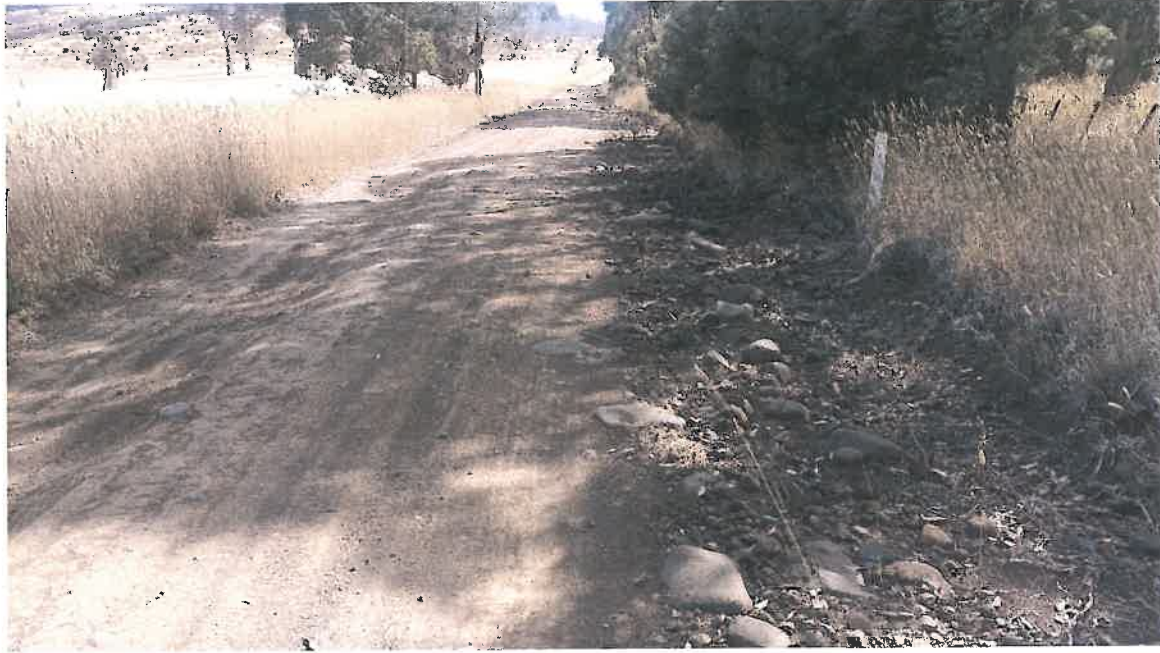
Figure 4 – Road surface rated as requiring 150mm overlay

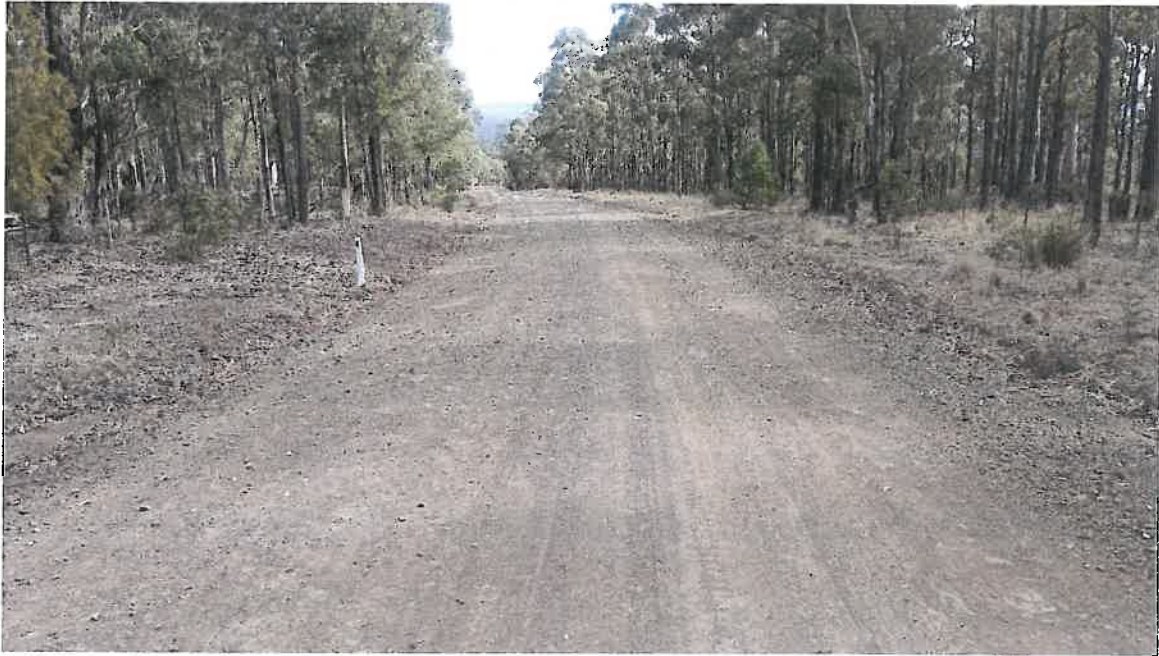
Figure 5 – Roadside drains and vegetation rated as Low level demand

The assessment found that in general, side drains were deemed functionally adequate and that specific improvement works are only required in isolated locations. The works associated with applying the gravel overlay assumes minor clearing and re-establishment of drainage channels will be included in the process. A rate of \$2,000.00 per kilometre has been included in the estimate to provide for localised deficiencies in sections rated as Low demand.

The assessment found that in general, roadside vegetation was deemed not to be adversely impacting road use and that vegetation trimming or removal works are only required in isolated locations. A rate of \$1000.00 per kilometre has been included in the estimate to provide for localised deficiencies in sections rated as Low demand.
