ORFORD FORESHORE MASTER PLAN

Draft Report

DRAFT ORFORD FORESHORE MASTER PLAN

Prepared for Glamorgan Spring Bay Council and Tasmanian Parks and Wildlife Service

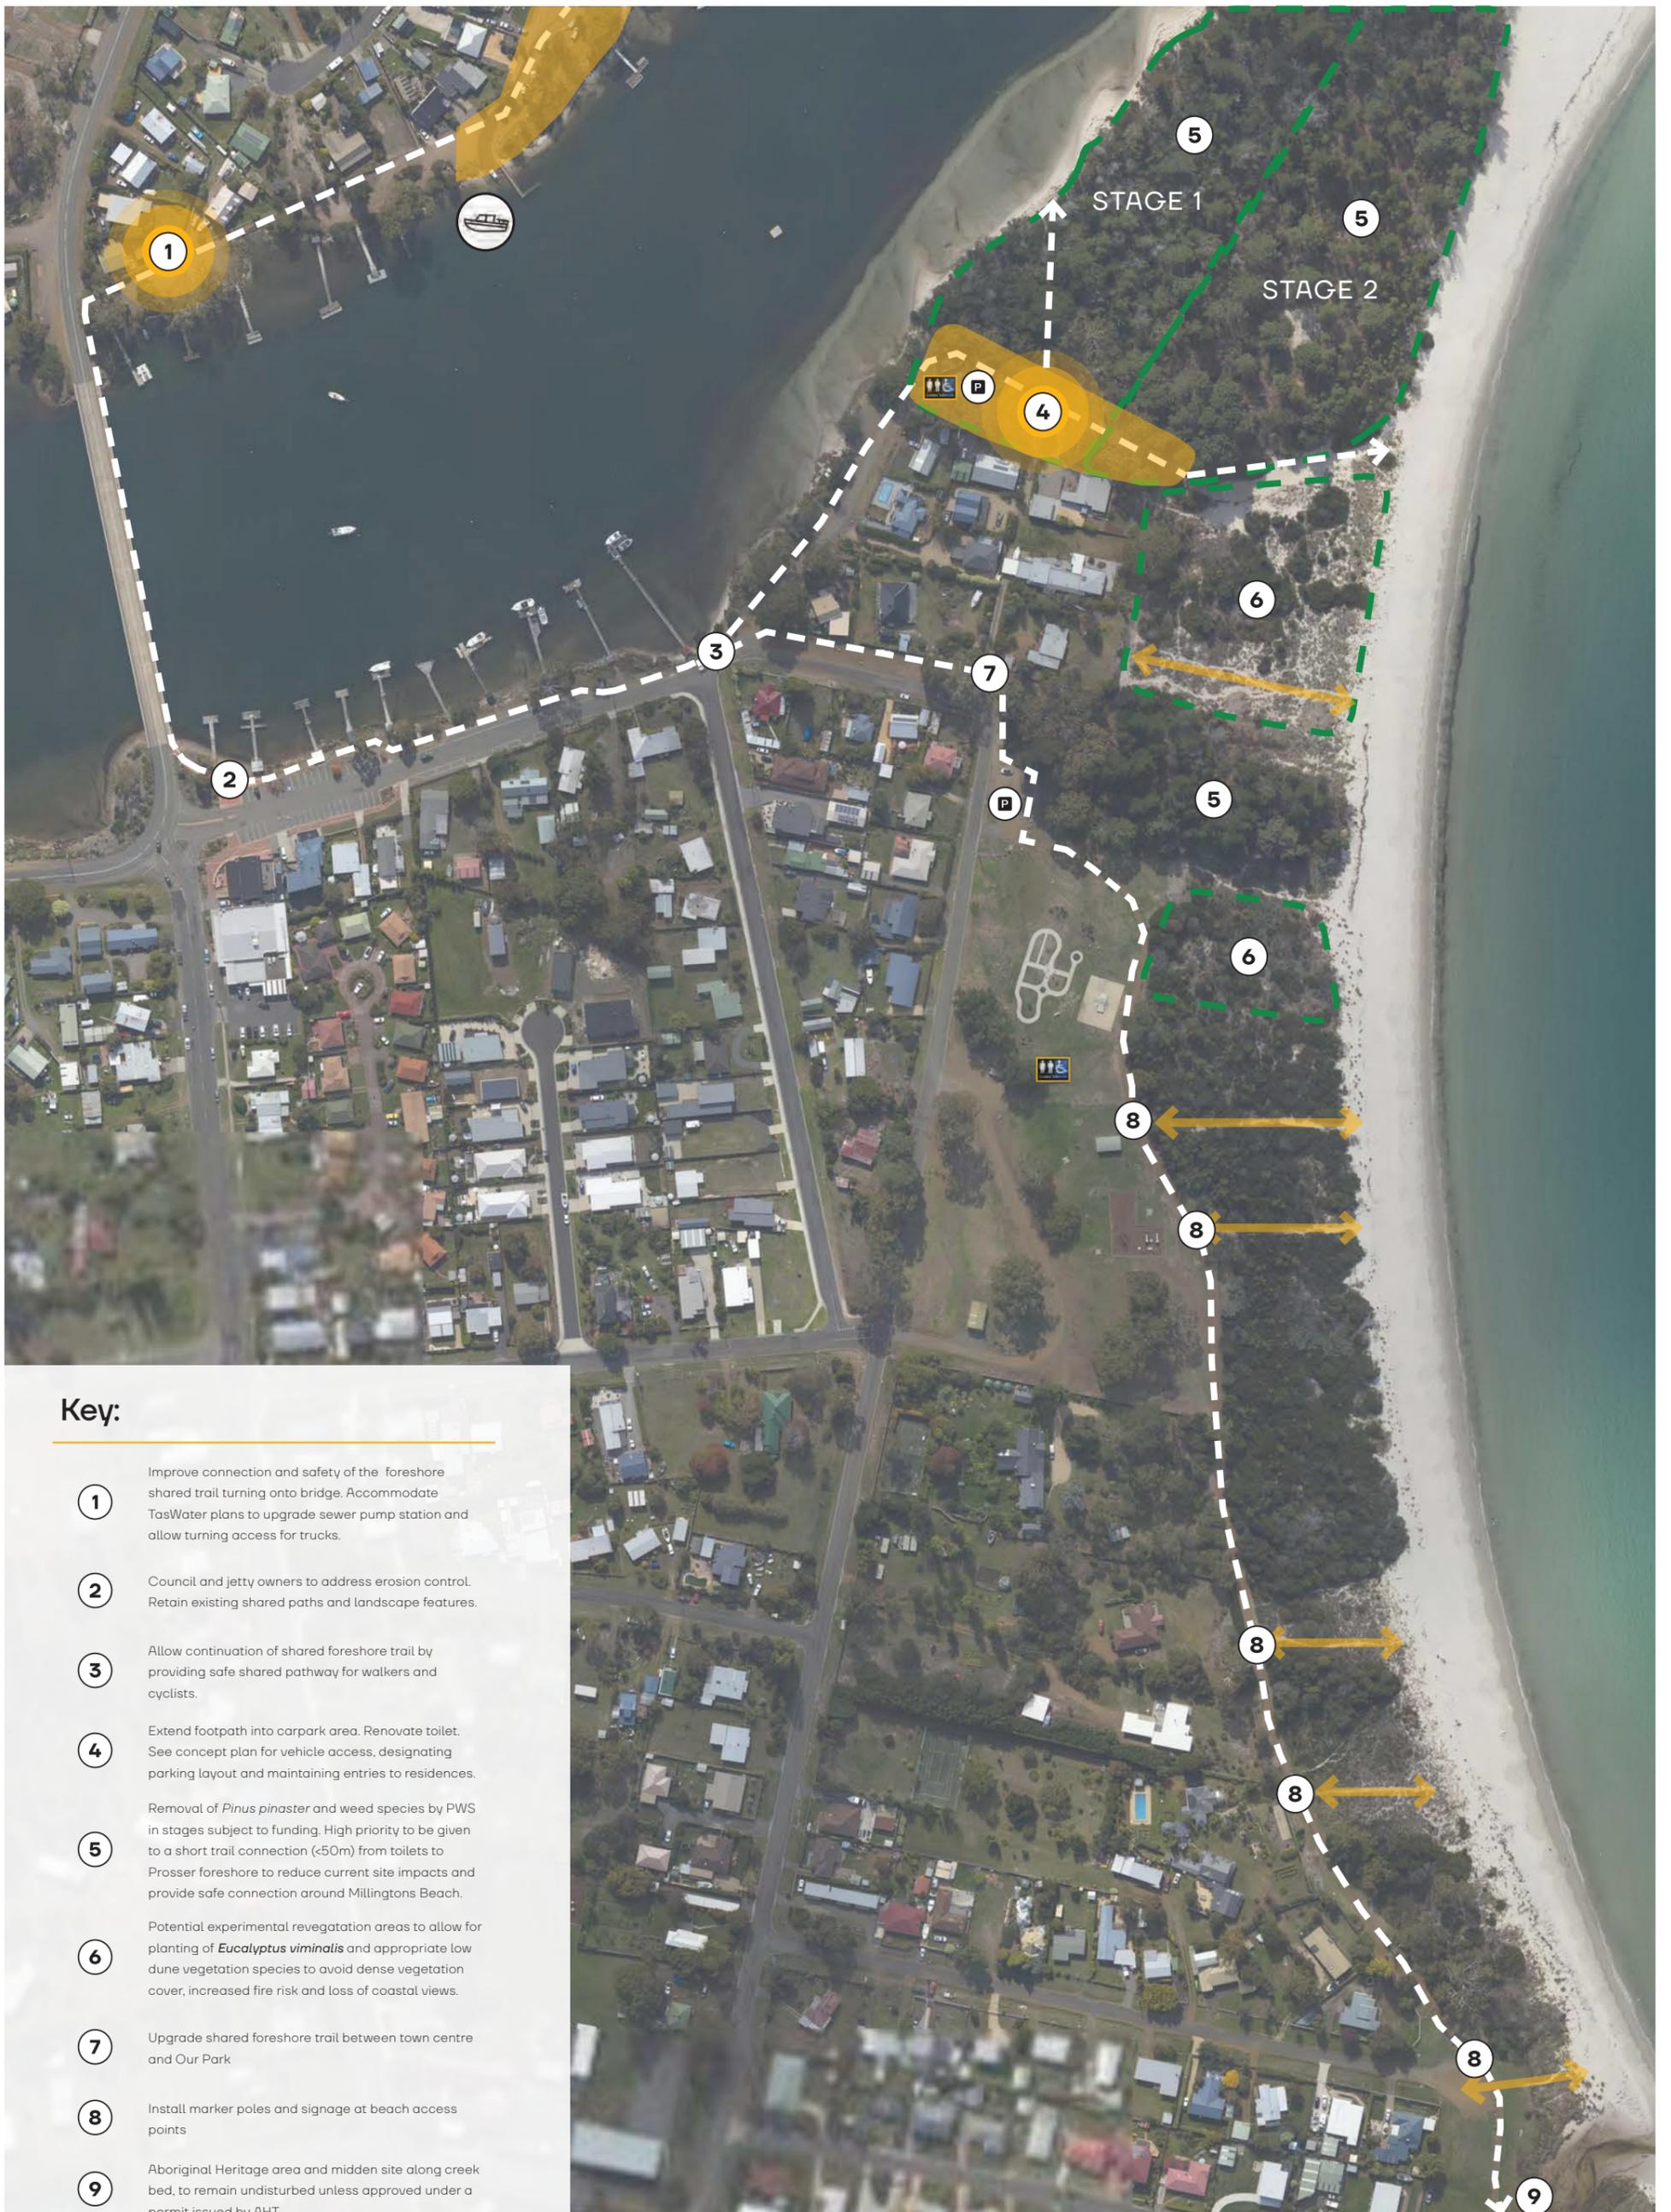
- ① Improve connection and safety of the foreshore shared trail turning onto bridge. Accommodate TasWater plans to upgrade sewer pump station and allow turning access for trucks.

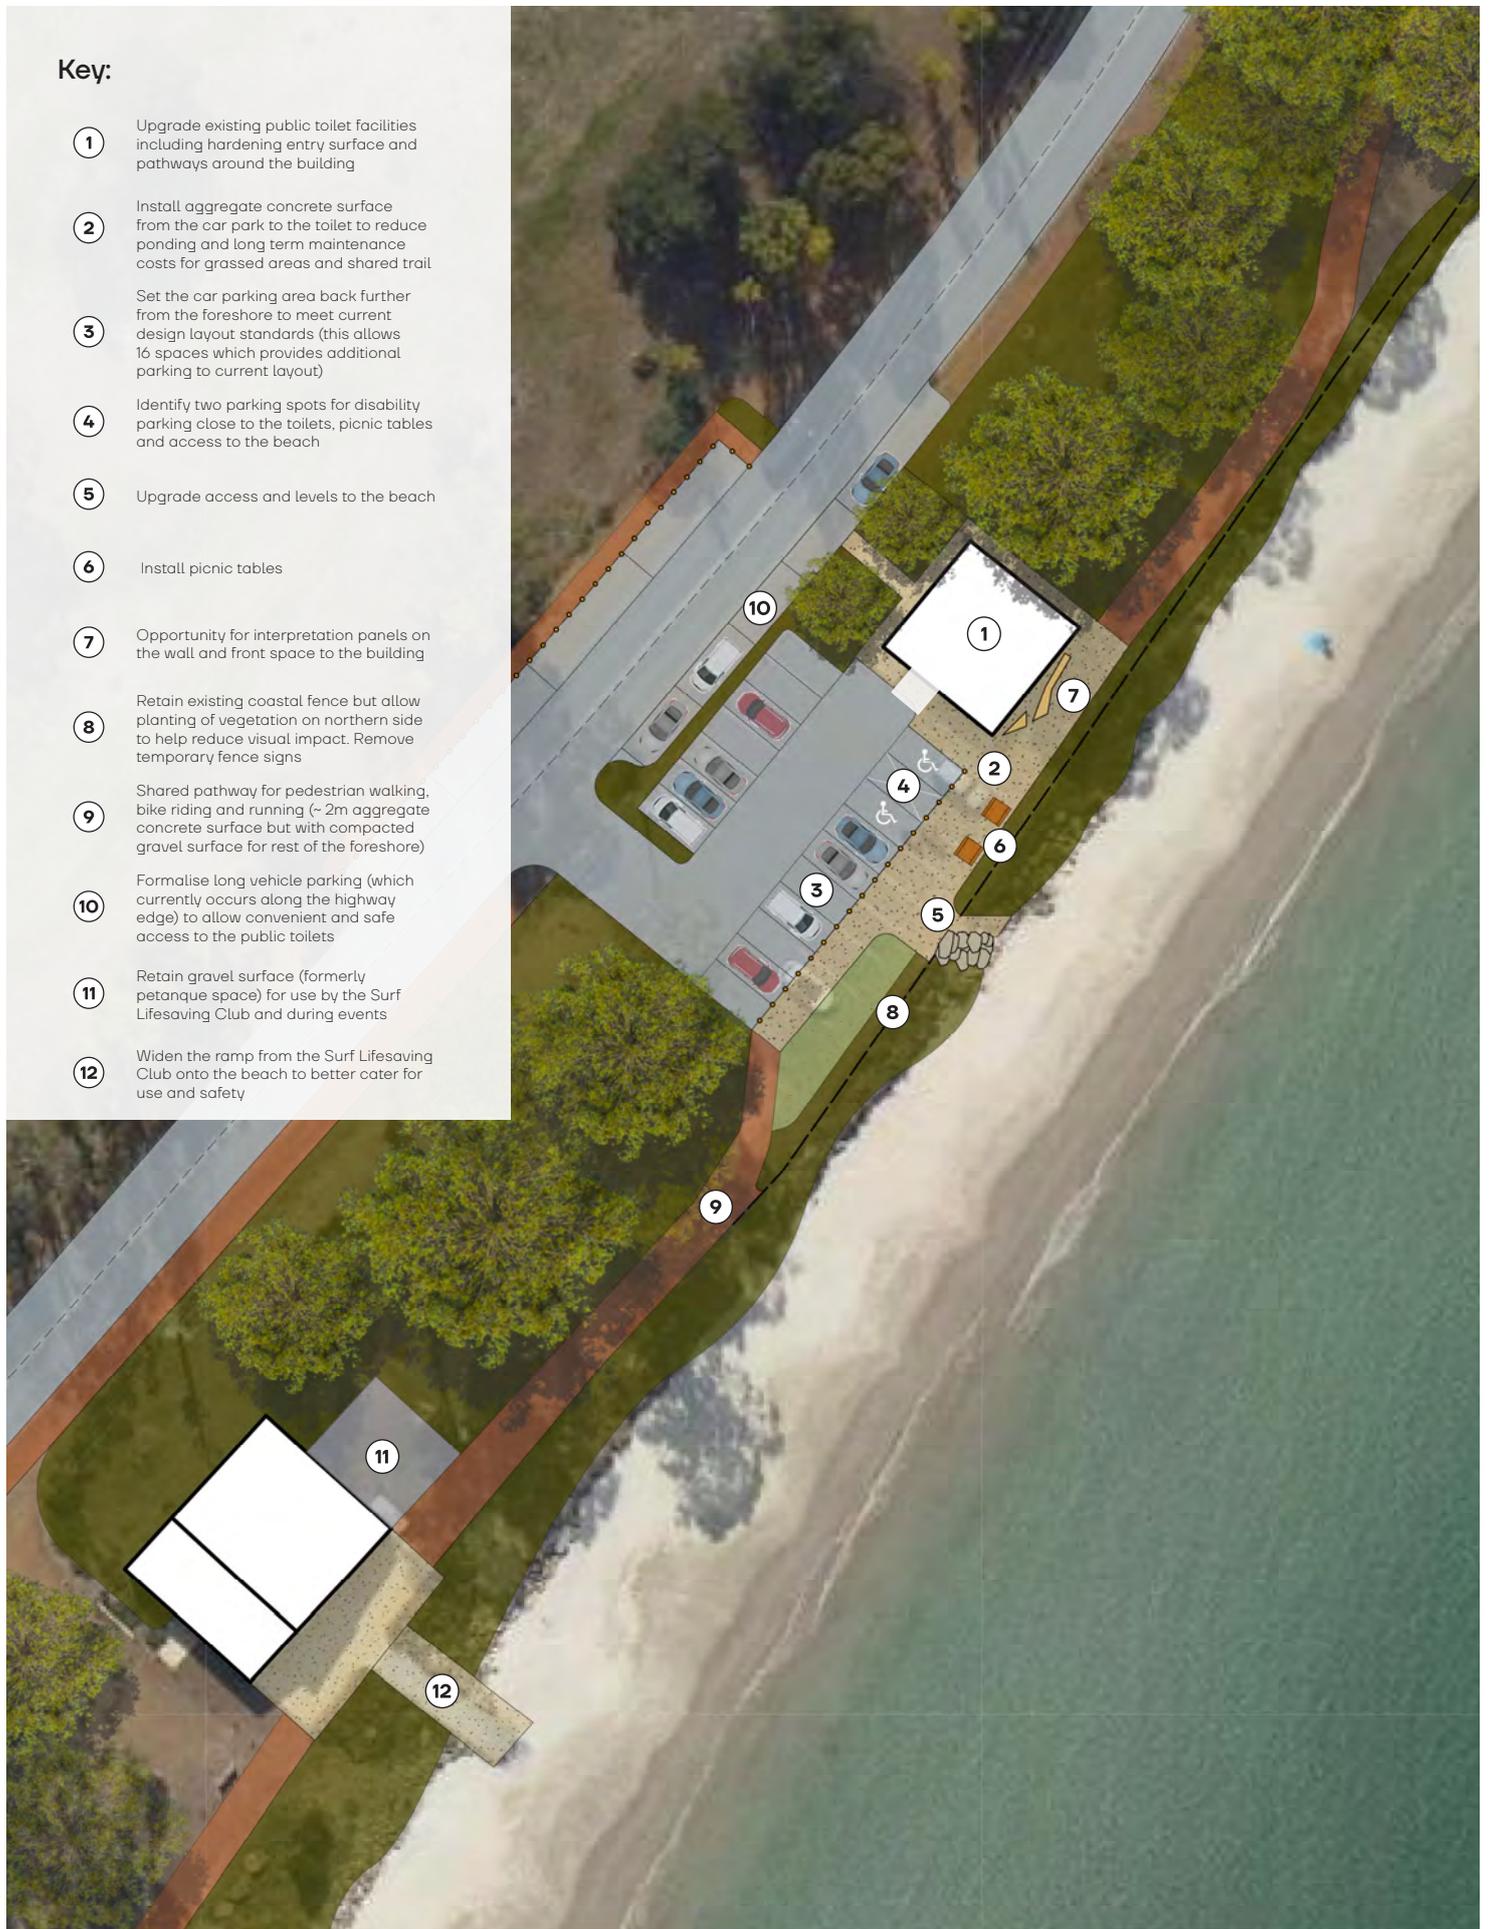
Map 3.4 Raspins Beach Conservation Area

- ⑩ Formalise long vehicle parking (which currently occurs along the highway edge) to allow convenient and safe access to the public toilets
- ⑪ Retain gravel surface (formerly petanque space) for use by the Surf Lifesaving Club and during events

- ⑫ Widen the ramp from the Surf Lifesaving Club onto the beach to better cater for use and safety

S13	Identify and seek future funding for the major works and improvements at Raspins Beach (refer to Map 3.4 Site Concept Plan)	PWS, Council
S14	Identify and seek future funding for the major works and improvements at Millingtons Beach (refer to Map 3.8 Site Concept Plan)	PWS, Council
S15	Prepare baseline surveys of the extent and condition of natural values at selected sites where visitor access and facilities exist	PWS
S16	Identify funding to allow an updated vegetation study to define the current extent and condition of threatened vegetation within the foreshore area.	PWS, Council
S17	Identify funding for investigation of aquatic flora of the Radar Beach backwater and Sheas Creek (at northern Raspins Beach) to assess potential occurrence of threatened flora species	PWS

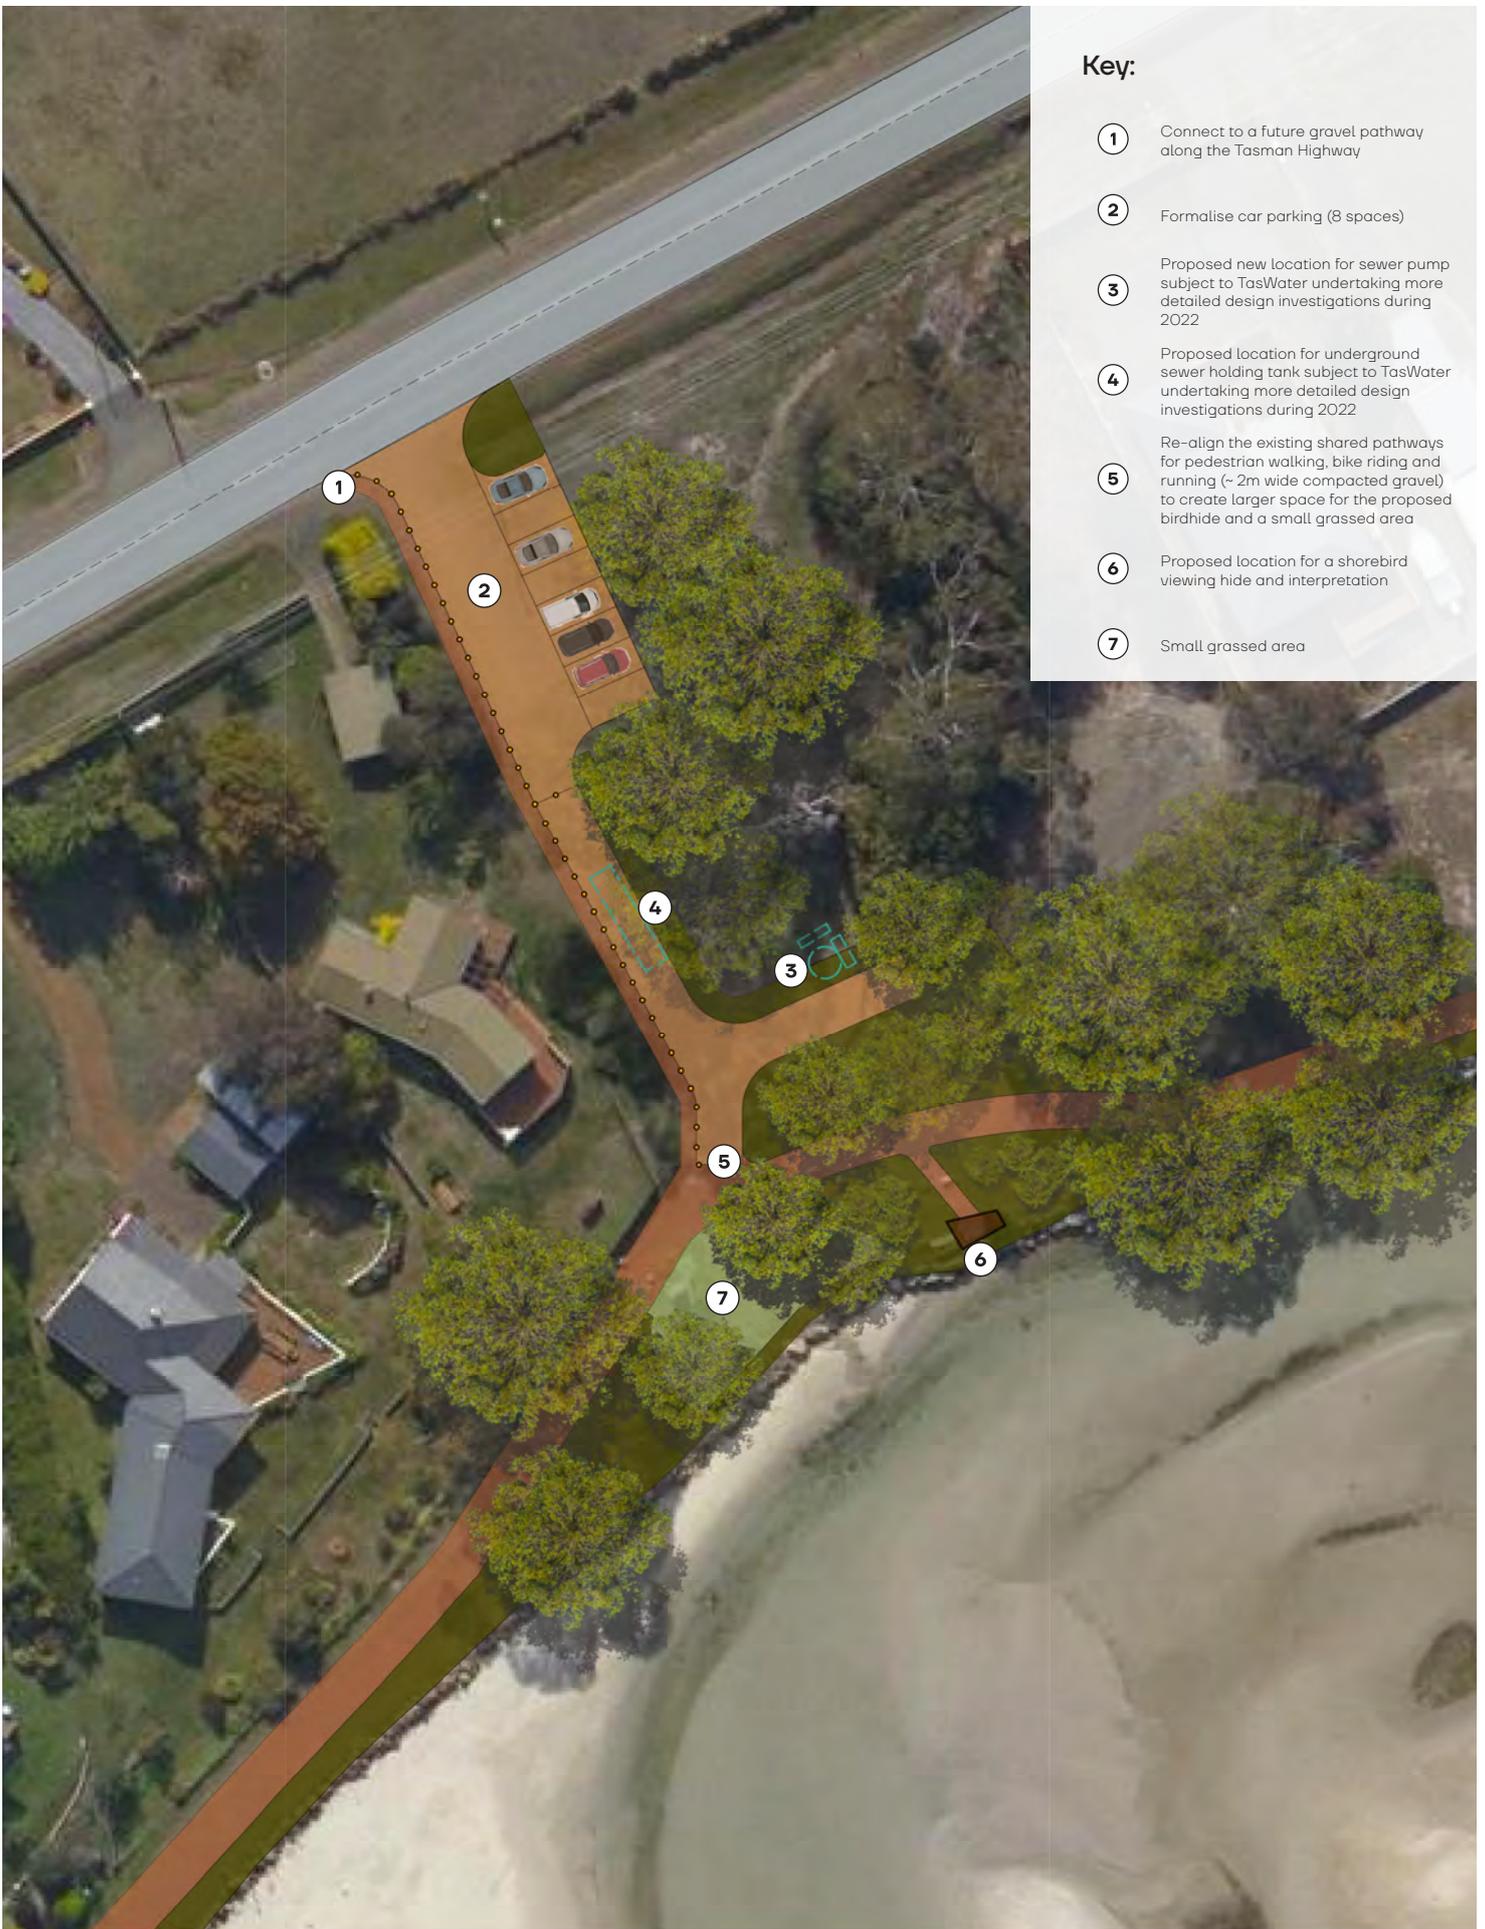
- ① Connect to a future gravel pathway along the Tasman Highway
- ② Formalise car parking (8 spaces)
- ③ Proposed new location for sewer pump subject to TasWater undertaking more detailed design investigations during 2022
- ④ Proposed location for underground sewer holding tank subject to TasWater undertaking more detailed design investigations during 2022
- ⑤ Re-align the existing shared pathways for pedestrian walking, bike riding and running (~ 2m wide compacted gravel) to create larger space for the proposed birdhide and a small grassed area
- ⑥ Proposed location for a shorebird viewing hide and interpretation
- ⑦ Small grassed area

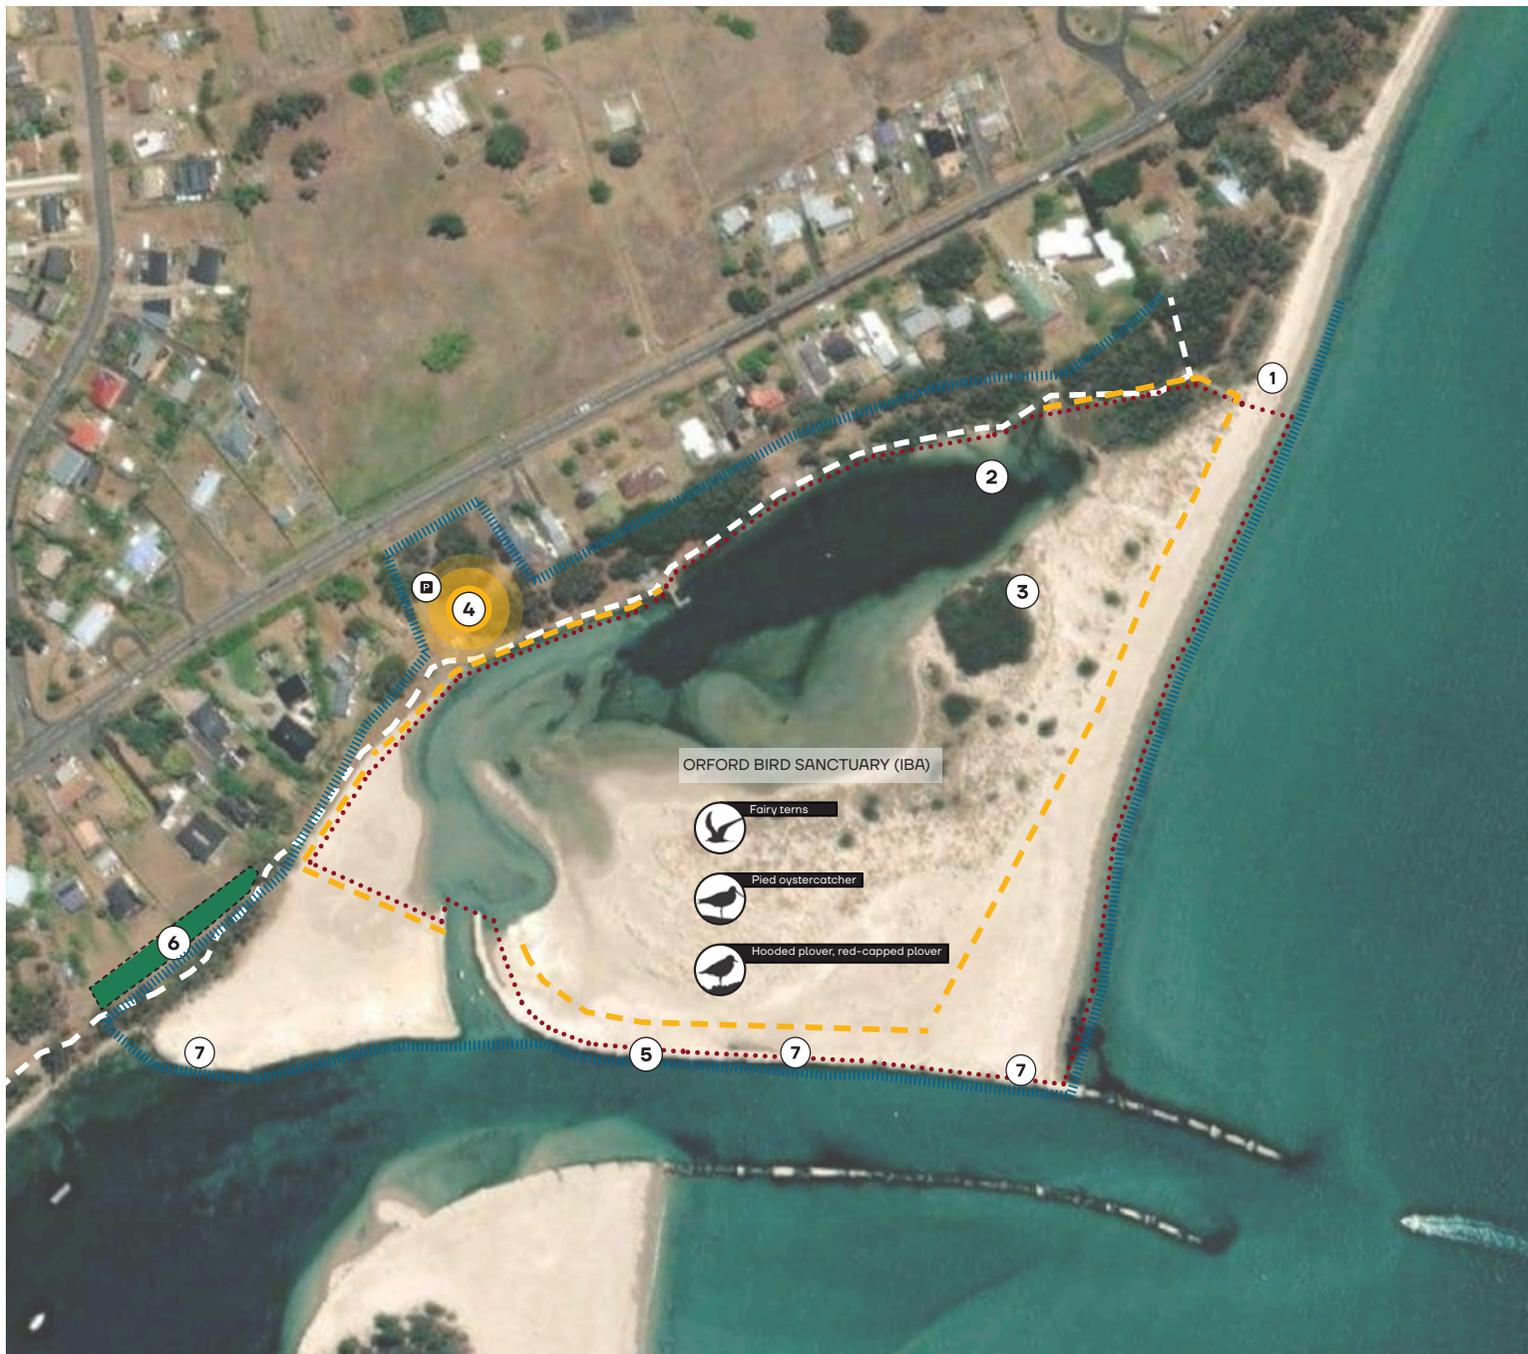
- ① Access to Raspins Beach at northern end of the Orford Bird Sanctuary. Upgrade management and interpretation signs at this location.
 - ② Undertake aquatic flora surveys of the Radar Beach backwater.

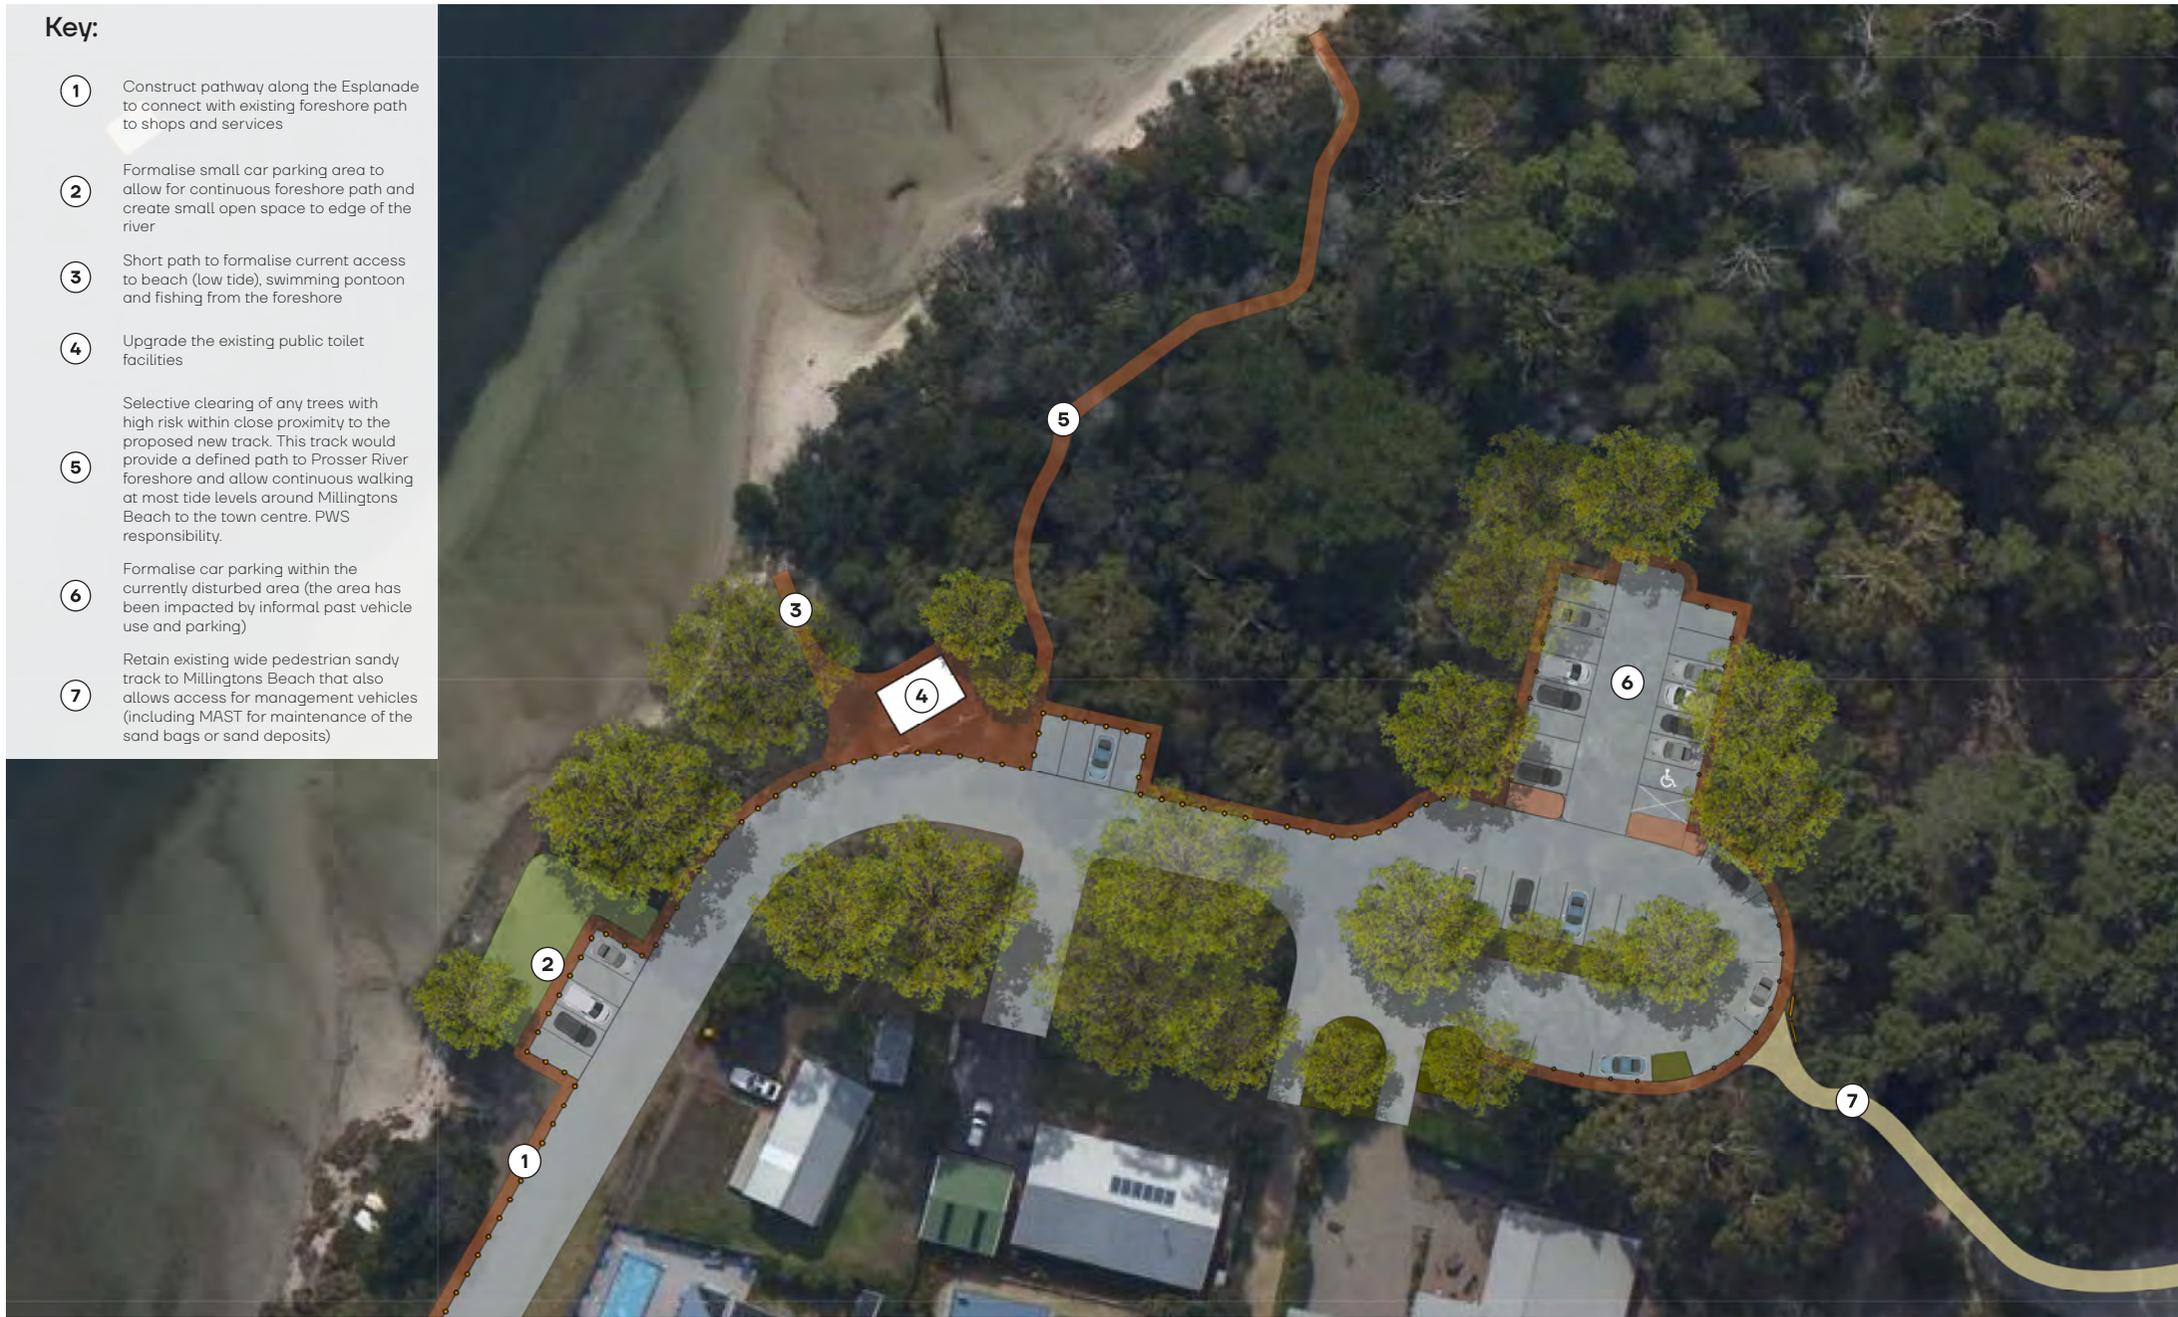
Map 3.9 Millingtons Beach Conservation Area Carpark Site Concept Plan

- ⑤ Selective clearing of any trees with high risk within close proximity to the proposed new track. This track would provide a defined path to Prosser River foreshore and allow continuous walking at most tide levels around Millingtons Beach to the town centre. PWS responsibility.

- ⑥ Formalise car parking within the currently disturbed area (the area has been impacted by informal past vehicle use and parking)
- ⑦ Retain existing wide pedestrian sandy track to Millingtons Beach that also allows access for management vehicles (including MAST for maintenance of the sand bags or sand deposits)

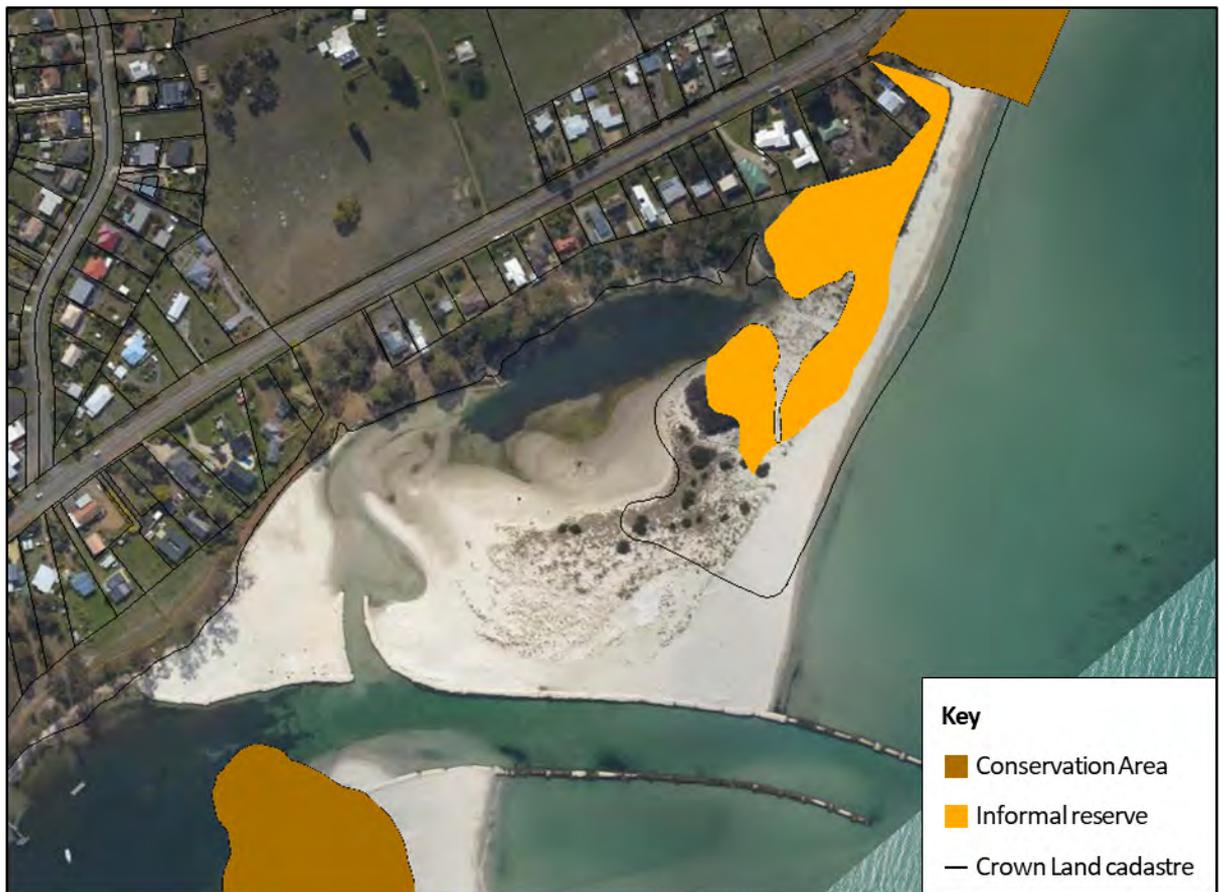
Reservation and cadastral boundaries around the area of the sandbar comprising the Orford IBA (brown areas to the north and south being Raspins Beach and Millingtons Beach Conservation Areas respectively, and the yellow area representing the extent of the informal reserve, noting that not even the Crown Land cadastral (black line) sufficiently covers the extent of the sandbar bird breeding habitat

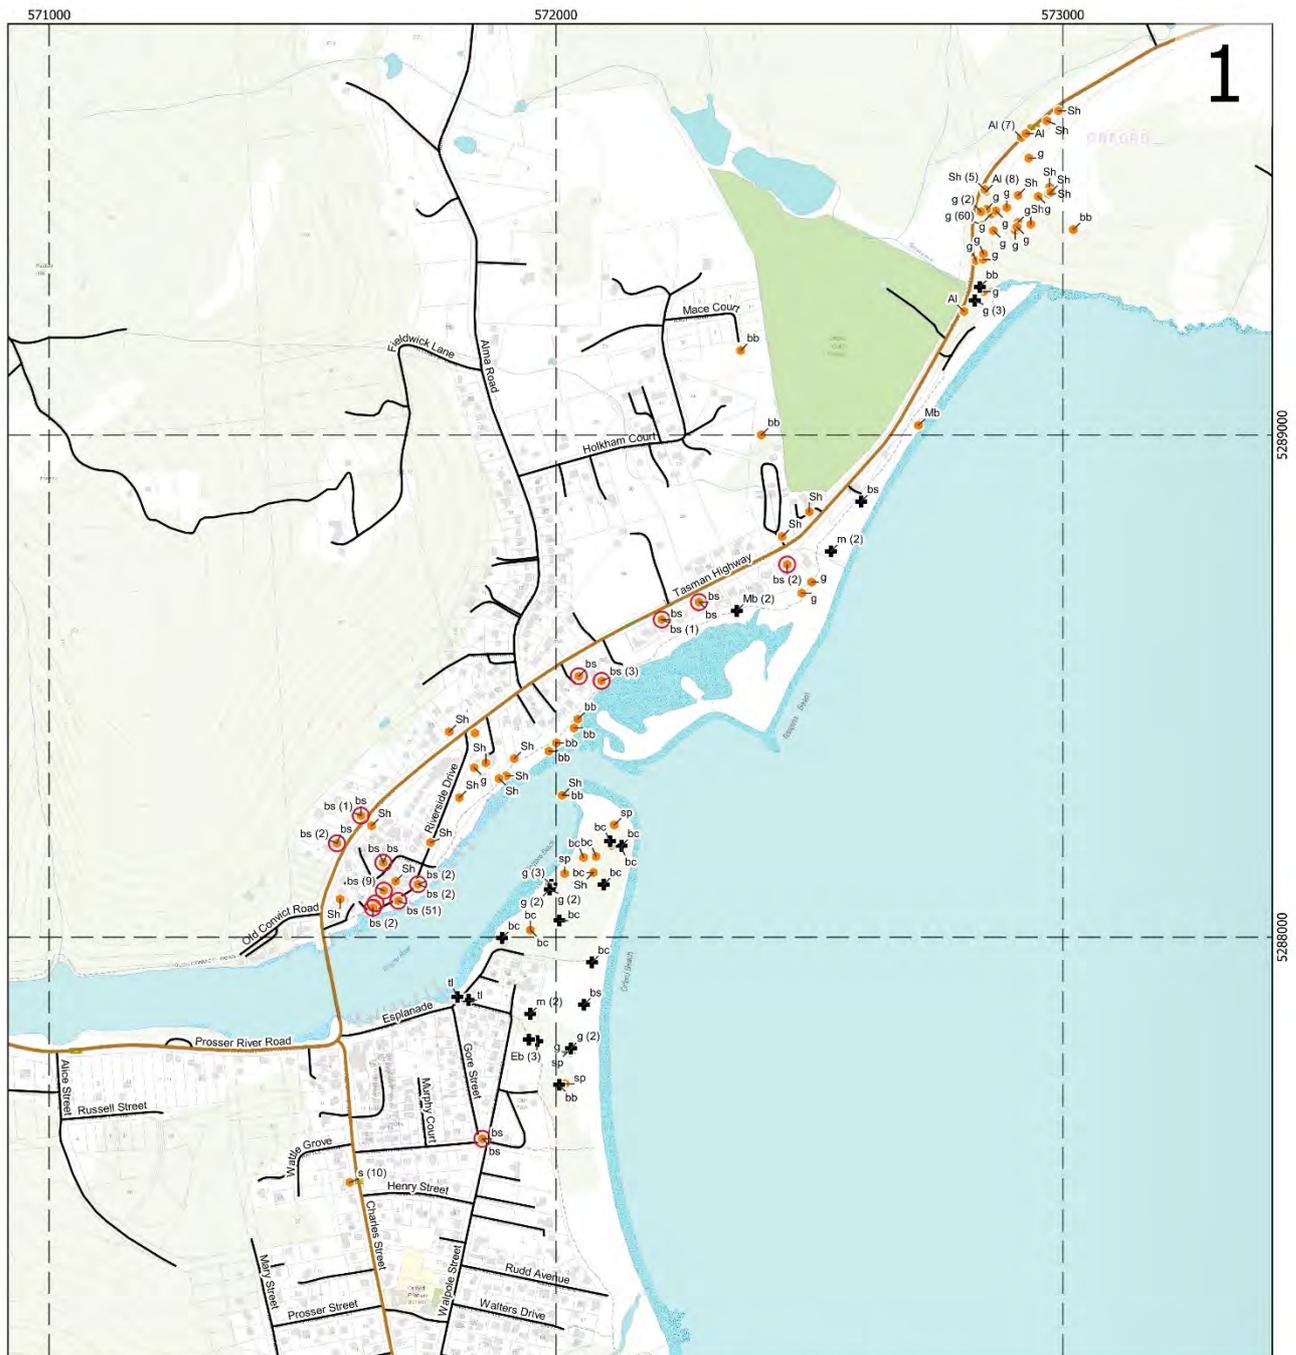
Figure 1: Indicative extent of declared and environmental weeds within the Orford Foreshore Area

NBES Declared and Environmental weeds

(labelled by species code and number of plants [if >1])

The mapping has been undertaken using a hand held GPS and subjective interpretation. Consequently it should be considered indicative only.
