GLAMORGAN SPRING BAY COUNCIL

PUBLIC TOILET **STRATEGY** **2025-2035**

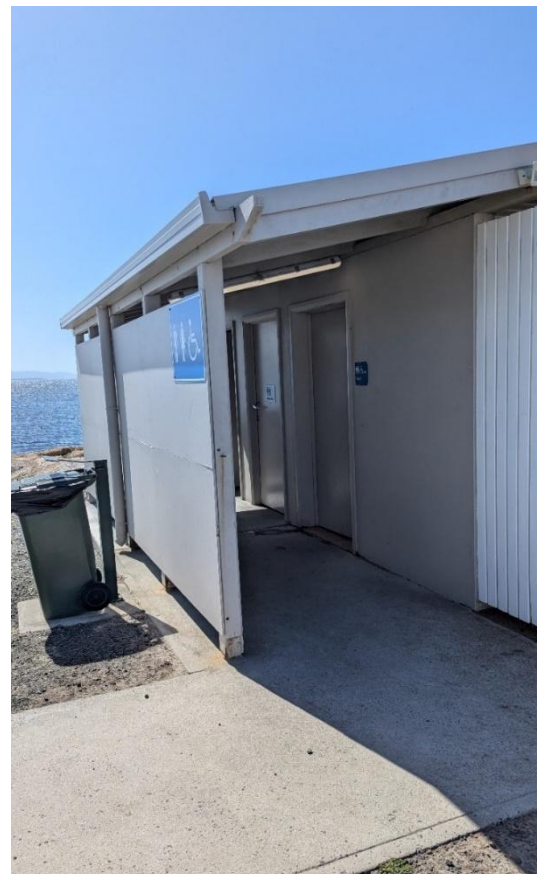
Below is a table showing the total amenity score for each of the 19 public toilets, the highest score that could have been achieved was 260. Each of the toilets were assessed on six categories: signage, aesthetics, safety, sanitation, access and gender.

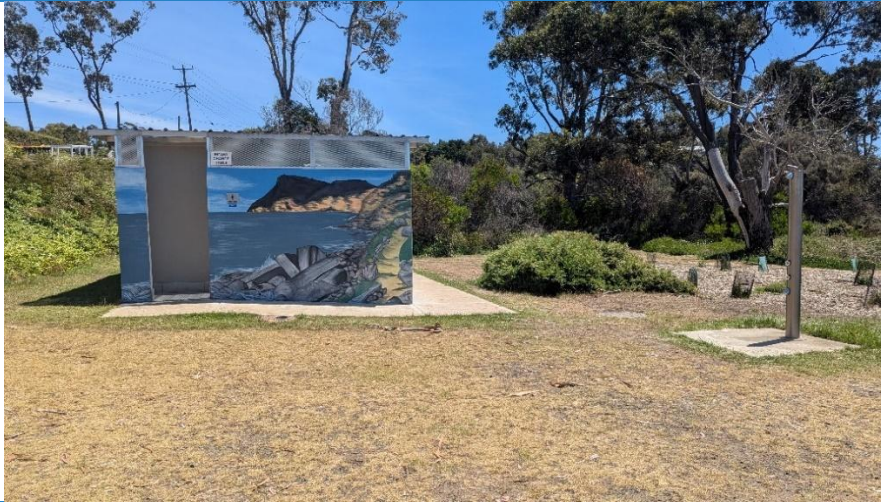
Spring Beach

This facility is small and not easily identified, it has had some recent works and serves beach goers effectively however, has not been designed with accessibility or CPTED principles in mind. The mural helps to soften the grey brick façade.

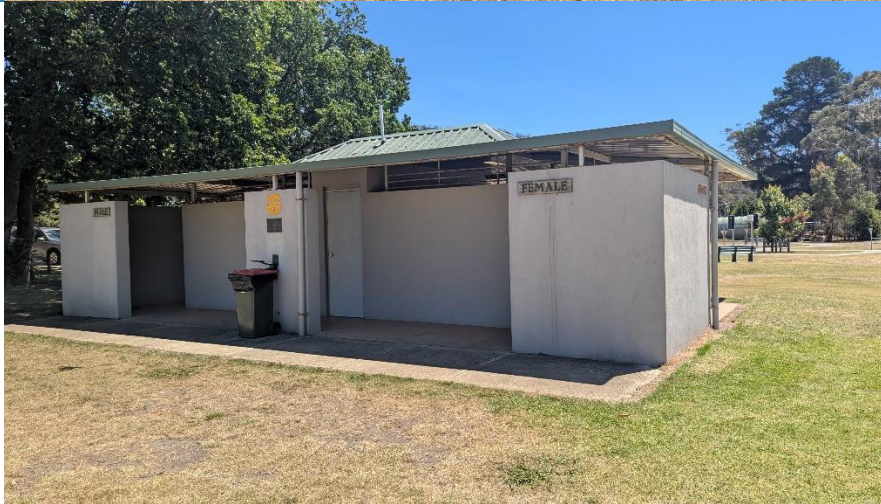
Our Park, Orford

The facility has been awkwardly placed in the park and causes viewing obstructions between park equipment. It is an older facility however it currently provides a good level of amenity to the park.

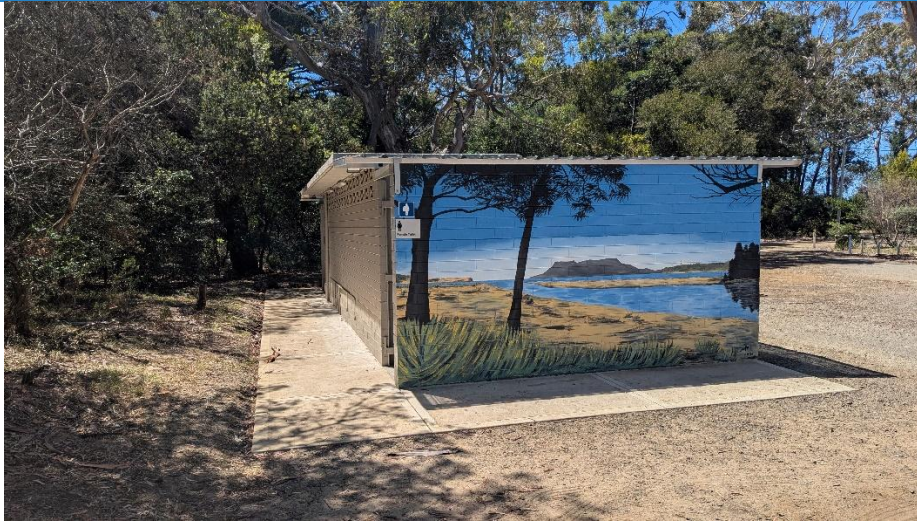
Esplanade, Orford

The facility has recently had some upgrades including the mural, it is an older facility which is lacking in amenity and was not developed with CPTED principles in mind. The painting mural does help to soften the traditional square grey look of older facilities.

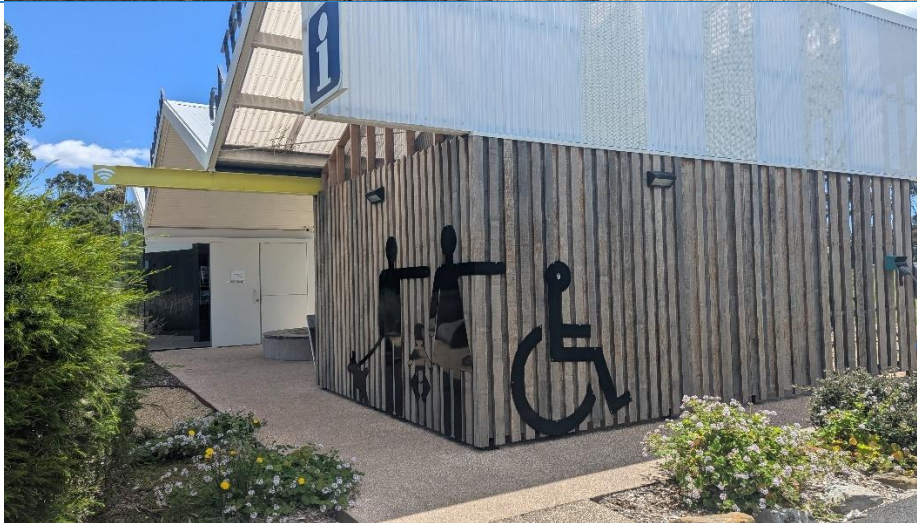
Gatehouse, Triabunna

Gatehouse has all the required amenities however, does have some structural downfalls including aggregate flooring that needs to be fixed.

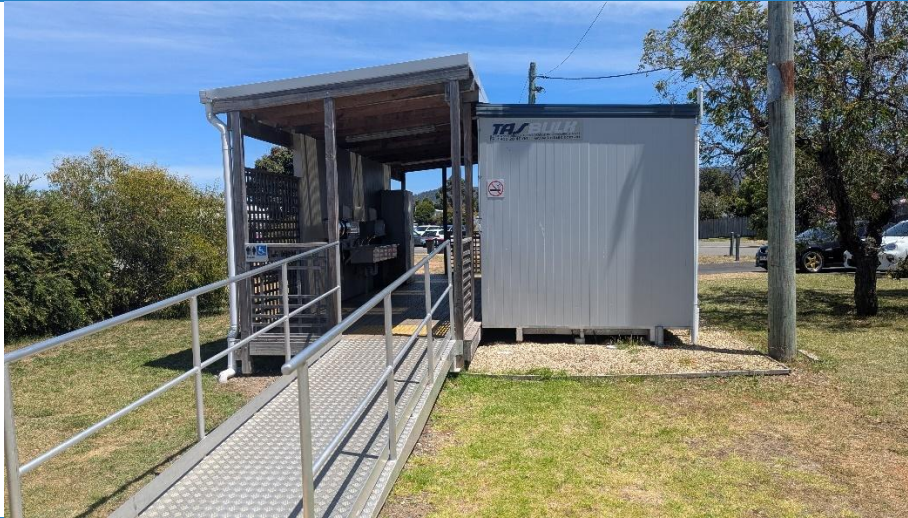
Marina, Triabunna

The demountables are proposed to be replaced and are intended to be reused somewhere else in the municipality. They are well designed and provide a good level of amenity.

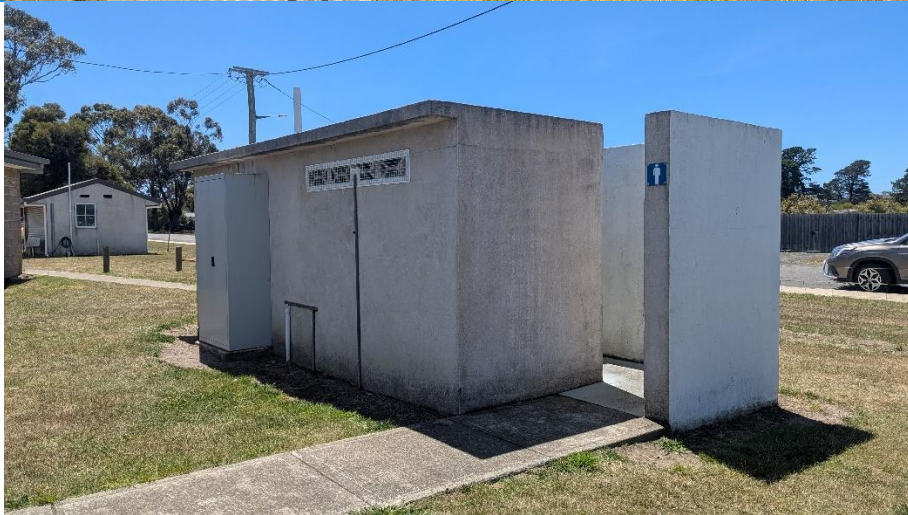
Triabunna Recreation Ground

This facility is very poor and aesthetically detracts from the area, it provides the barest minimum of amenity.

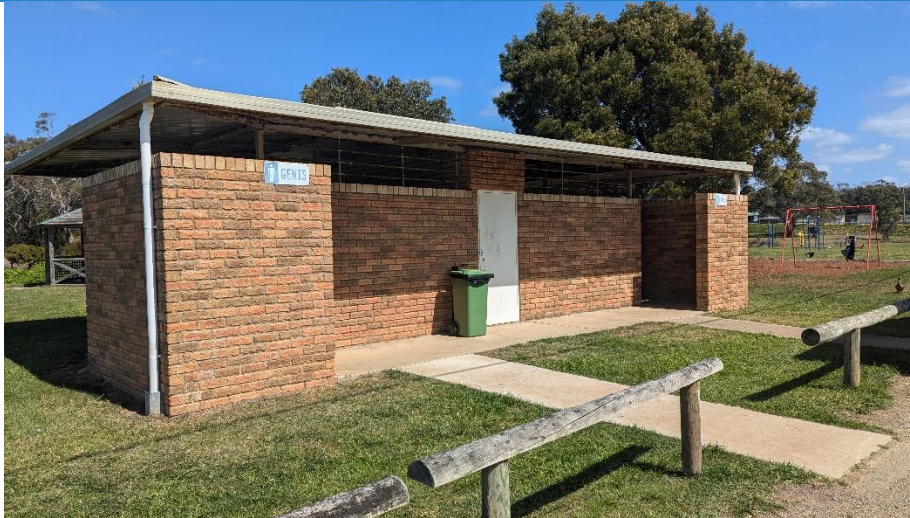
Duck Park, Swansea

The facility services the park well and provides a good level of amenity and no immediate improvements were identified.

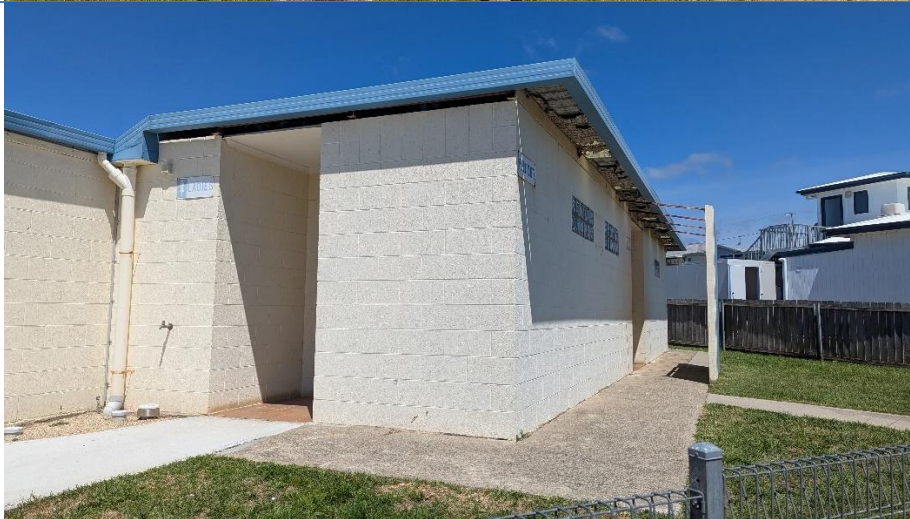
Swansea Recreation Ground

Facility is becoming run down and has poor ventilation, however is in a good location to service the recreation ground and near by businesses. The facility has had ongoing works done to it, but could benefit with a significant renovation or replacement.

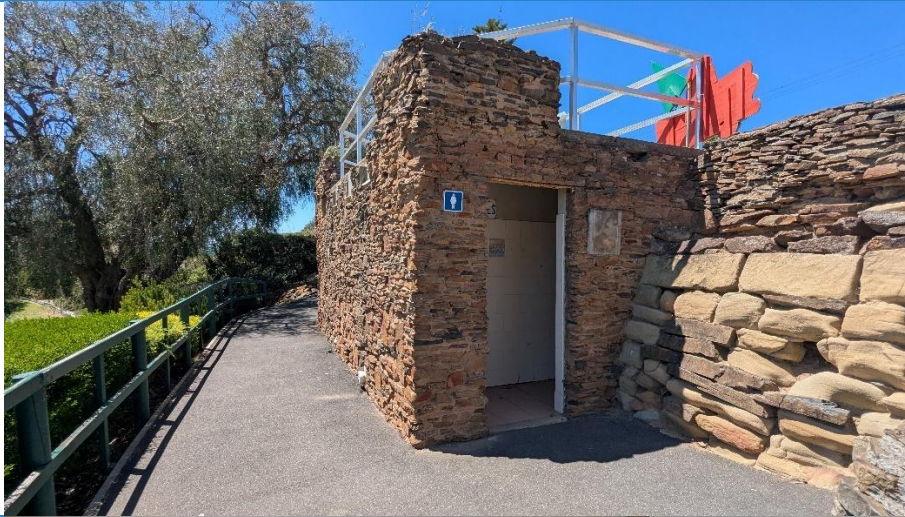
Jubilee Park, Swansea

These toilets work in conjunction with the 'loo with a view'. They are an interesting placement and design and provide a good level of amenity to Jubilee Park and foreshore users, they could be updated and improved with additional amenities.

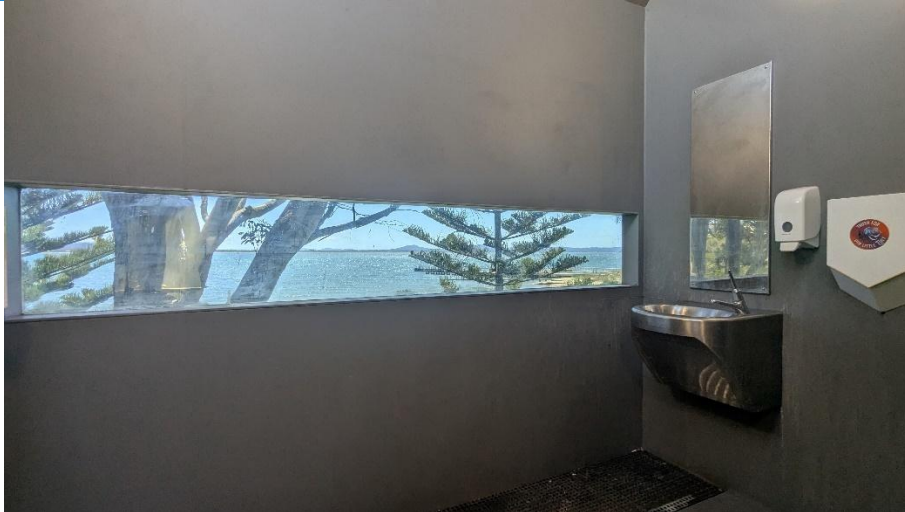
Loo with a View, Swansea

The facility provides a high level of amenity and provides a disability compliant toilet that adheres to CPTED principles. However, has ongoing issues with the flushing system which the works department have been rectifying.

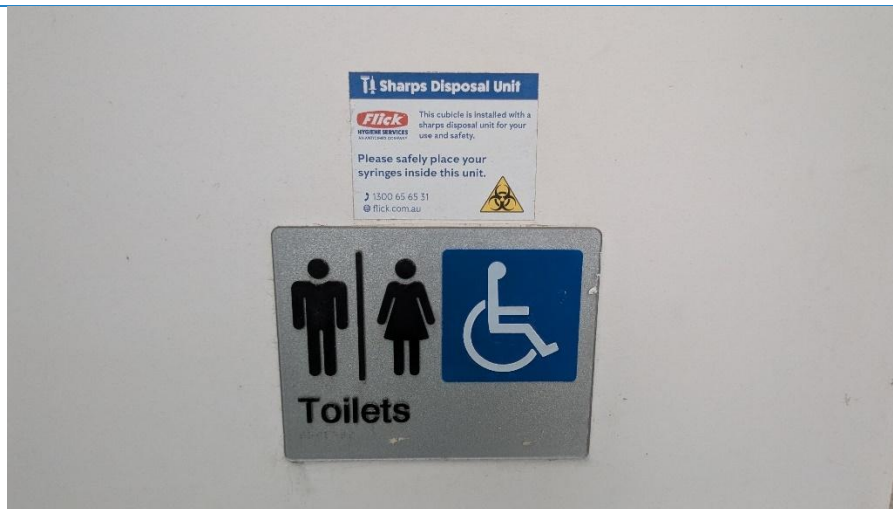
Swansea Museum

The toilets provide a good level of amenity for museum users, there is no sign outside of the museum to show the facilities are available to the public.

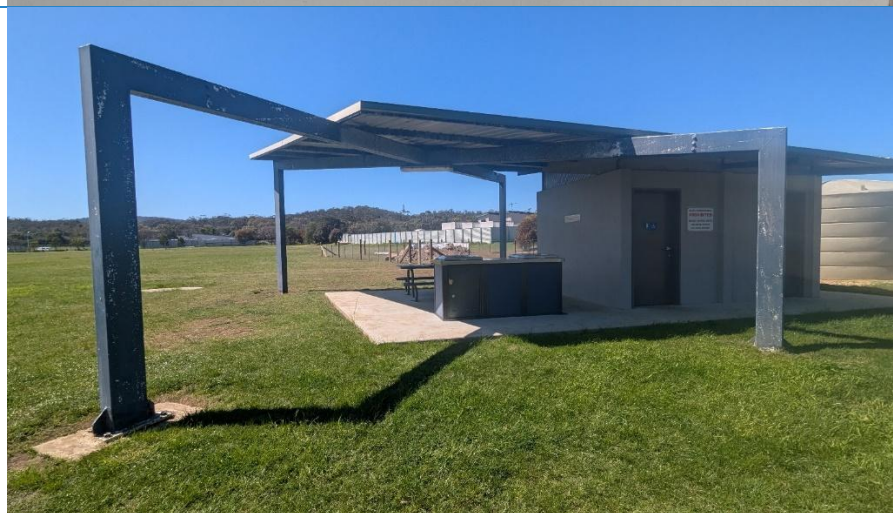
**Hazards View Dr,
Swanwick**

This facility provides a good level of amenity however despite being disability compliant there is no flat, level path to the facility for people using wheel chairs or walking aids.

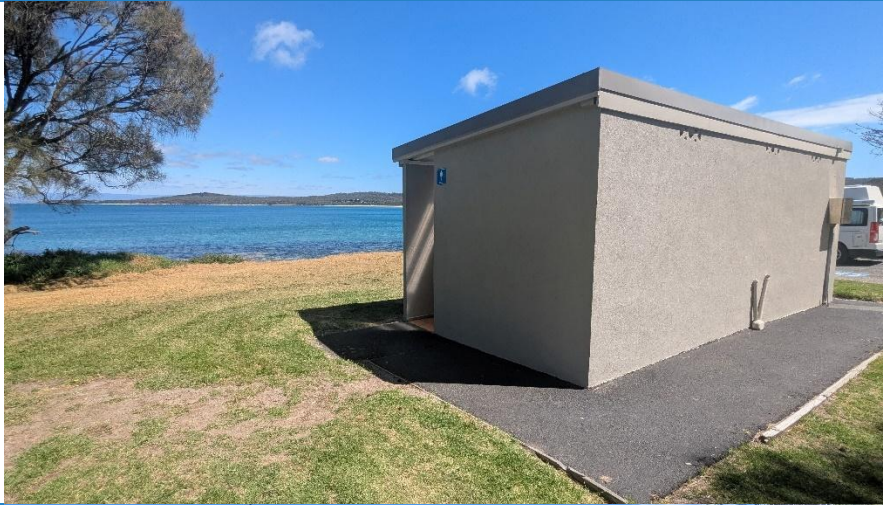
Muir's Beach, Coles Bay

The toilet aesthetically detracts from the area and is reaching the end of the facilities life cycle and is in need of replacement.

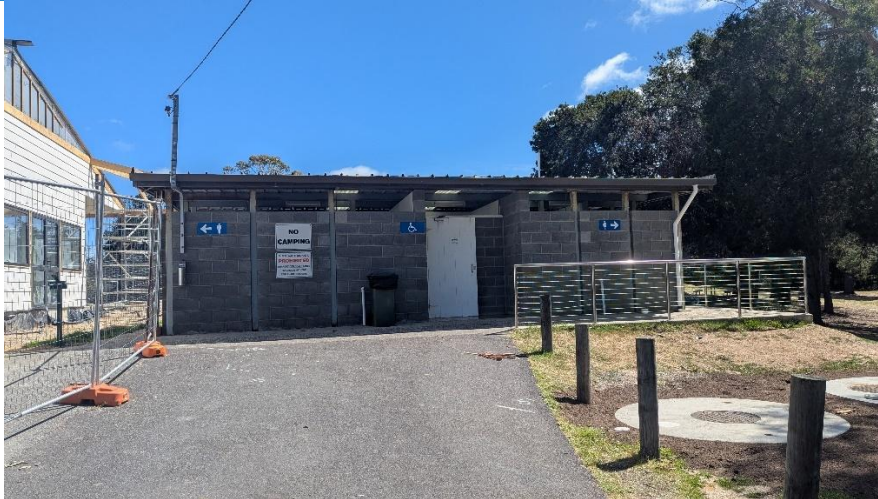
Coles Bay Community Hall

The facility has had ongoing issues with the septic system that are currently being addressed by the works department. Otherwise provides a good level of amenity.

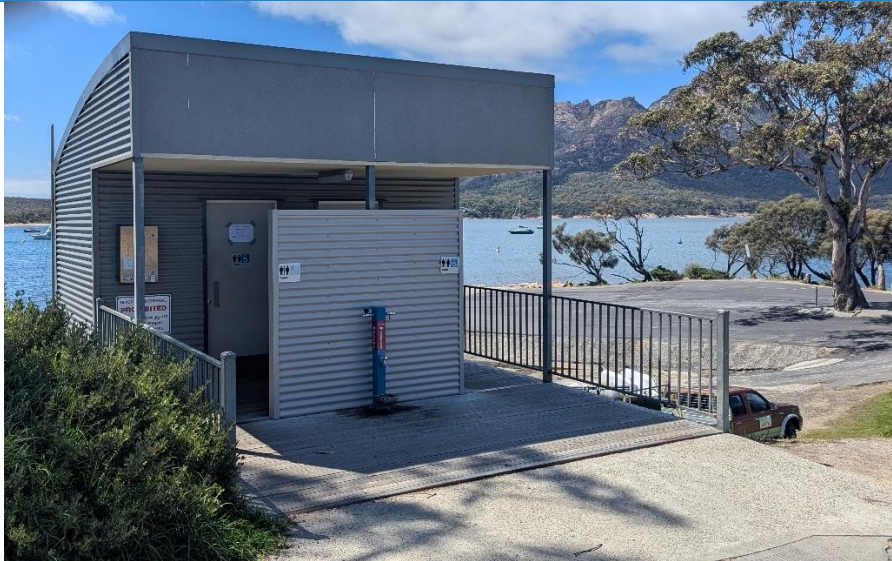
Coles Bay Boat Ramp

High level of amenity and located in a high use area.
Is relatively modern and meets CPTED principles.

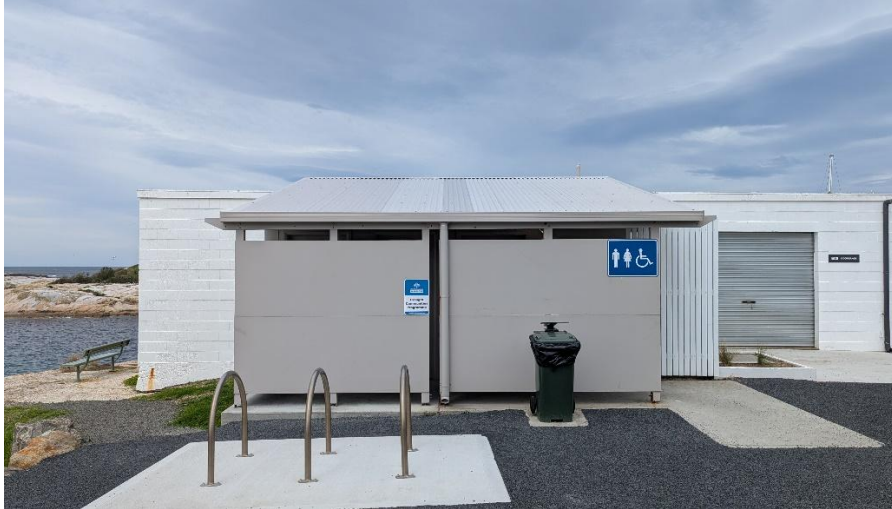
The Gulch, Bicheno

The front of the toilets could have more
transparency to provide better passive surveillance
of the area, otherwise they provide a good level of
amenity and service to most people.

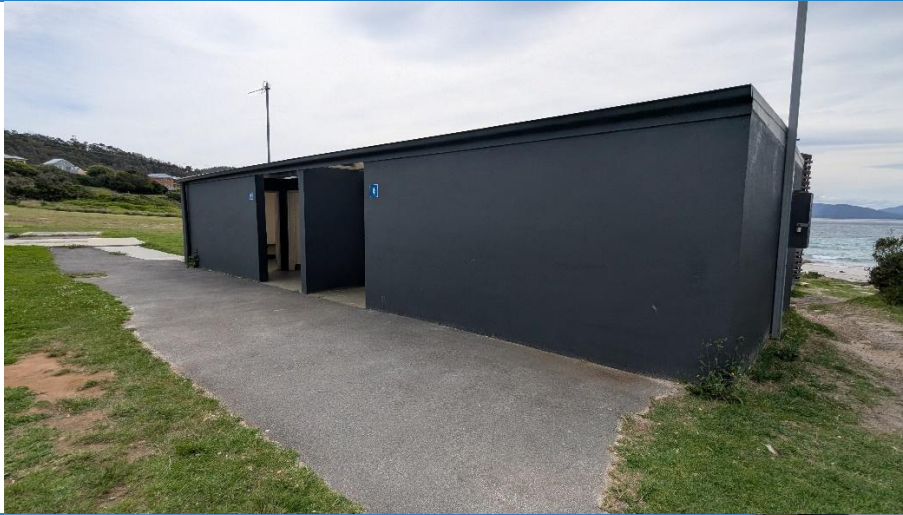
Jetty Beach, Bicheno

The toilets are potentially being upgraded / replaced depending on level of funding secured. The facility internally is very dated and run down and has poor ventilation.

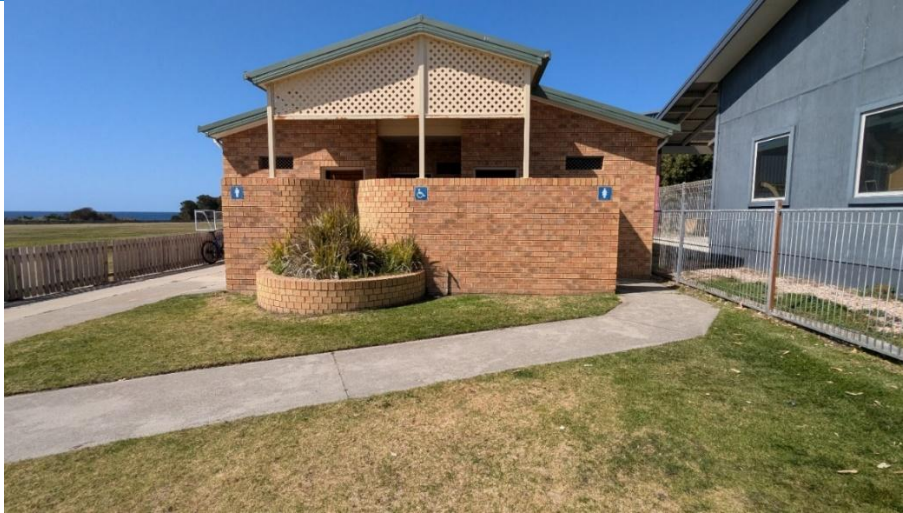
Bicheno Recreation ground

The disabled access toilet requires people to go past the entry to the female toilets and the walls screening the entry into the toilets causes a potential safety issue, the toilets are older but service the recreational ground adequately.
