1533 Dolphin Sands Rd, Dolphin Sands 7190

Proposal:	New Dwelling	Scale: 1:1000	Job No: 186 - 2018	Pg No: DA.01		
Client:	Tim & Sarah O'Connor	Date: XX/XX/XX	Engineer:			
Address: 1533 Dolphin Sands Rd, Dolphin Saradsn71RN Building Surveyor:						
PINNACLE DRA	PINNACLE DRAFTING & DESIGN. CC6073Y 2 Kennedy Drv, Cambridge 7170 P: 03 6248 4743 F: 03 6248 4745 E: jnickerson@pinnacledrafting.com.au

COASTAL VULNERABILITY ASSESSMENT

1533 Dolphin Sands Road, Dolphin Sands

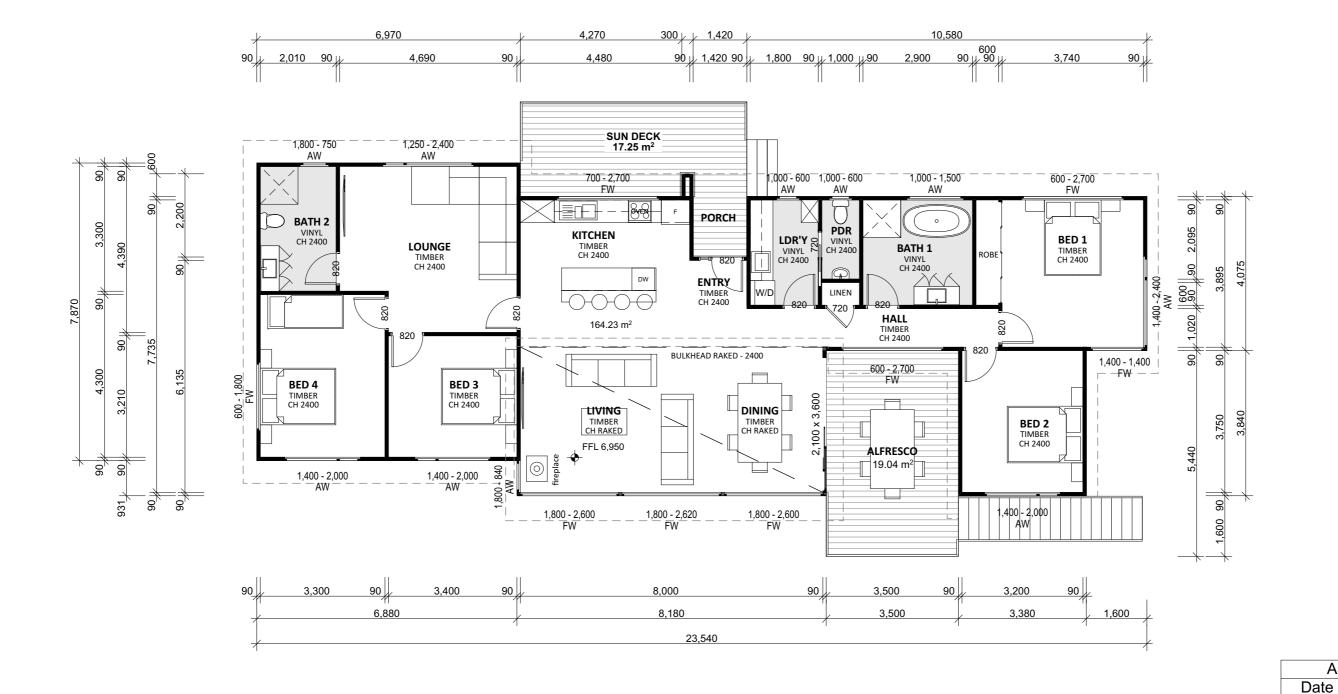
Floo	or Pl	an

Floor Areas						
Floor Area	162.20 sqm					
Deck	17.64 sqm					
Porch	4.85 sqm

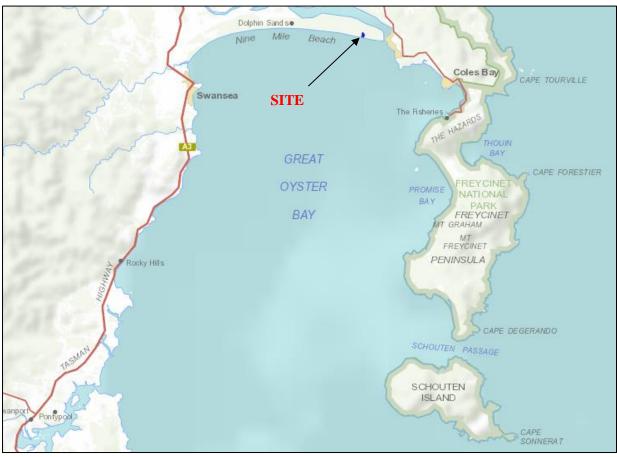
Figure 1 Regional Location of Project Area - The Land and Information System, Tasmania (LIST)

The Project Area is located at Dolphin Sands and fronts on Nine Mine Beach (Figure 1).

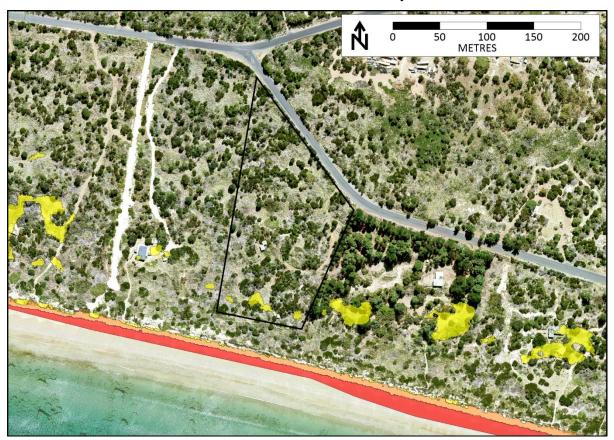
Figure 4 IPAC Overlay near the Site

Part of the site resides within the Coastal IPAC Low Hazard overlay.

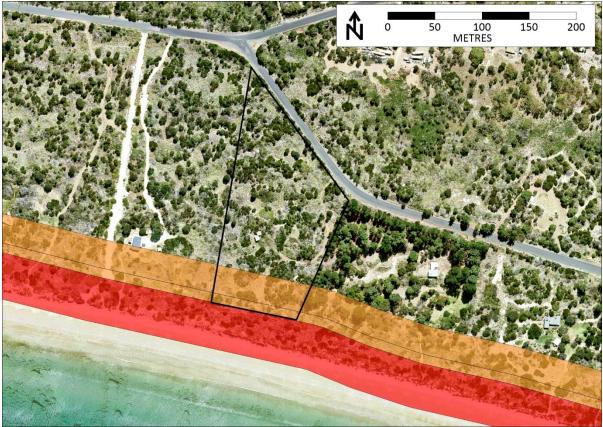
Figure 5 CEHC Overlay near the Site

Part of the site falls within the coastal erosion hazard overlay (Figure 5).

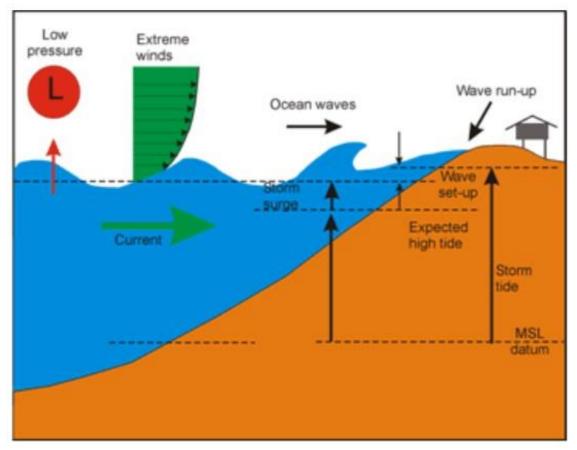
Figure 7 Hydrodynamic Parameters Associated with Storm Surge Events

As wind setup, wave setup and wave runup normally occur simultaneously during storm surge events, these components are combined with extreme tide and storm surge predictions to provide maximum inundation levels for the site. Wave models have been generated for the site to define the site specific hazards.

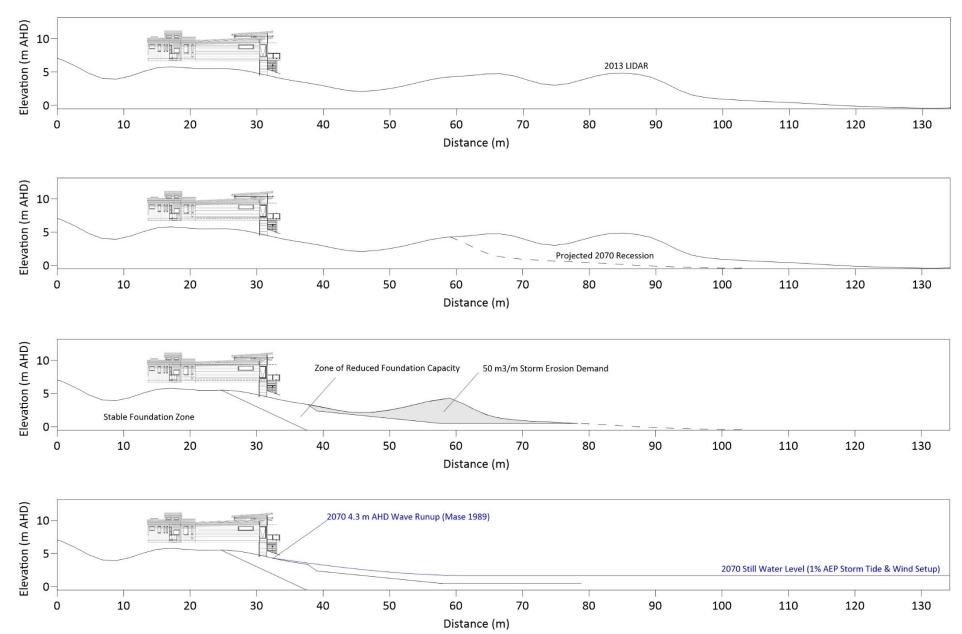
Figure 9 Site Cross Sections Demonstrating 2070 Recession, 50 m³/m Storm Erosion Demand, and Inferred Inundation Levels & Wave Runup Extent

A stable foundation zone assessment has been conducted for the site. The basis behind this particular assessment involves the use of Nielsen et. al. (1992) methods for assessing stable foundation zones in sand. A cross section has been constructed through the site to indicate the worst case scenario 2070 sea level rise scenario based on recession modelling (Figure 9 & Figure 10). The storm erosion demand has been constructed based on Nielsen et. al. (1992) equations which use a 1:10 post storm gradient.

A coastline recession of 30 m horizontal is recommended for the site by 2070 based on the 2013 LIDAR Survey

A storm erosion demand of 50 m3/m is recommended for the investigation

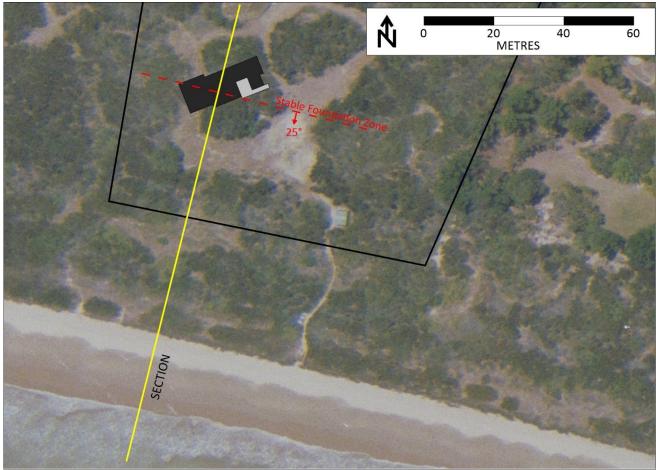
Figure 10 Stable Foundation Zone Extending at a 25° Angle Towards the Coastline

- Design storm erosion demand and 2070 coastline recession estimates are applied to the 2013 beach
 profile in a stable foundation zone analysis to determine the likely position of the stable ground by 2070.
 From the analysis it is determined that the proposed building foundations are set within the 2070 stable
 foundation zone;

- The main frontal dune is projected to be eroded by 2070, and wave runup has the potential to overtop the frontal dune and migrate inland.

- The proposed development will need to be founded within the stable foundation zone. Most of the building envelope already resides within the stable foundation zone. Foundations will need to extend deeper on the coastal side of the stable foundation zone delineation; and
- The finished floor level is well above the identified 2070 wave runup level.

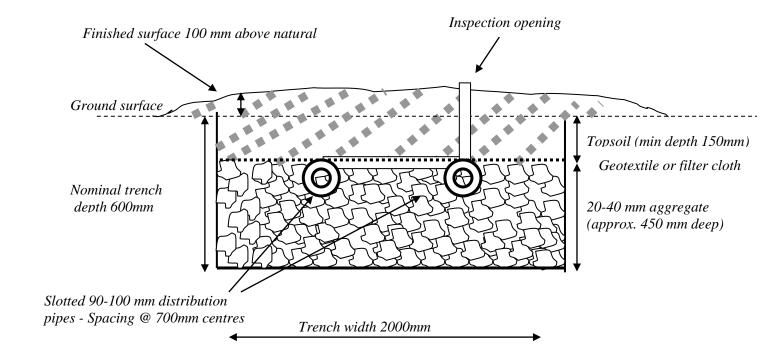
Figure 1 – absorption trench

- 1. Absorption trench dimensions of up to 25m long by 0.6m deep by 2m wide.
- 2. Base of trenches to be excavated level and smearing and compaction avoided.

Slotted 90-100mm pvc pipe @ 700mm spacing with a splitter box to ensure even distribution

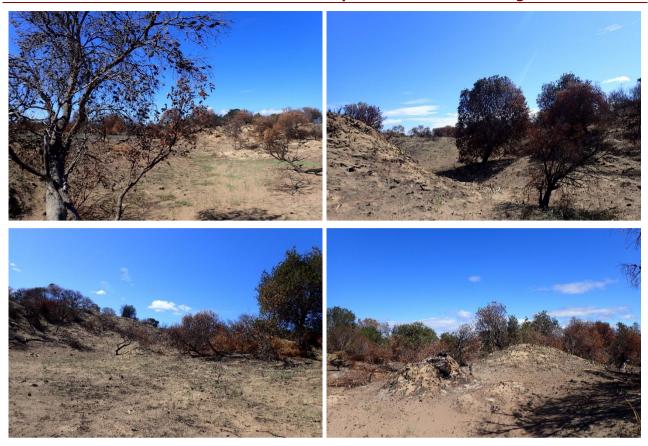
Plates 1-4. Examples of recently burnt SAL in the northern part of the title

Refer to Plates 1-8.

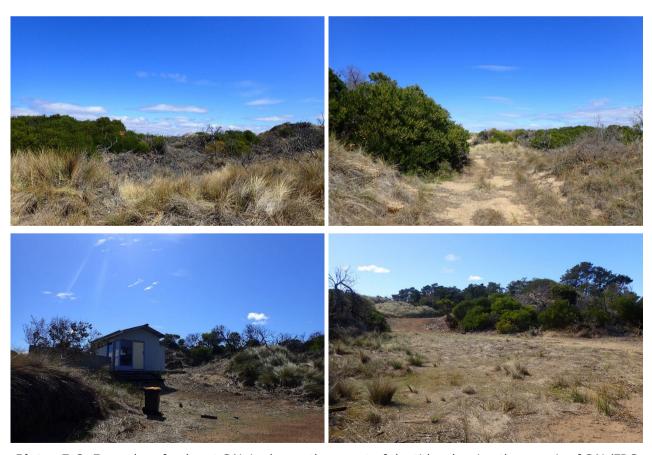
Plates 5-8. Examples of unburnt SAL in the southern part of the title, showing the mosaic of SAL/FRG (top two images) and existing areas of disturbance subsumed into SAL (lower two images)

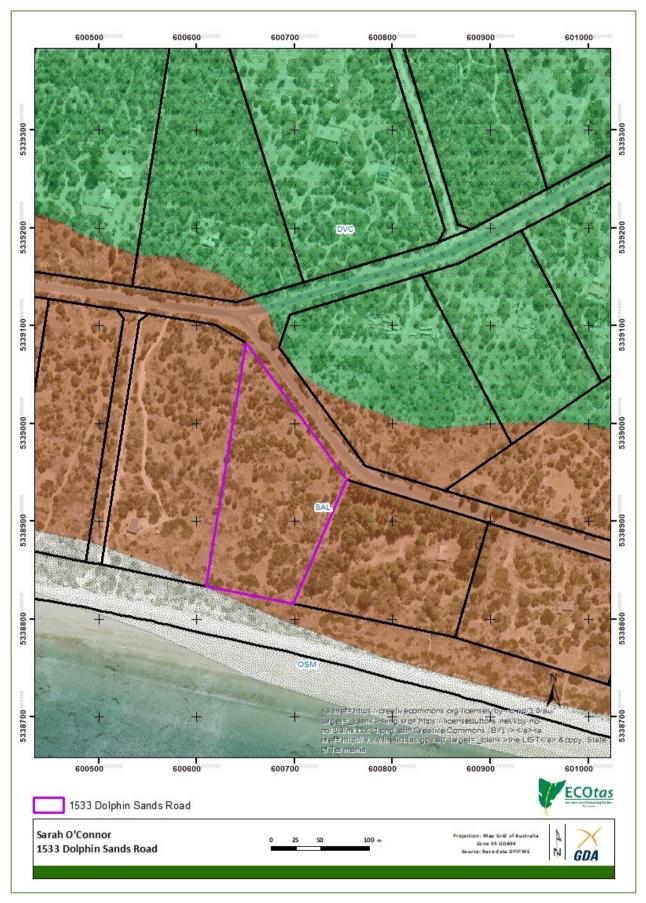
Figure 5. Existing TASVEG 3.0 and TASVEG Live vegetation mapping for the subject title and surrounds (refer to text for codes) [source: TheList]

The vegetation type identified from the subject title is classified as threatened under Schedule 3A of the Tasmanian *Nature Conservation Act 2002*, does not equate to a threatened ecological community under the Commonwealth *Environment Protection and Biodiversity Protection Act 1999*, and are classified as low priority biodiversity values under the *Glamorgan-Spring Bay Interim Planning Scheme 2015*. There are no sites identified from within the title that require special management with respect to vegetation types.

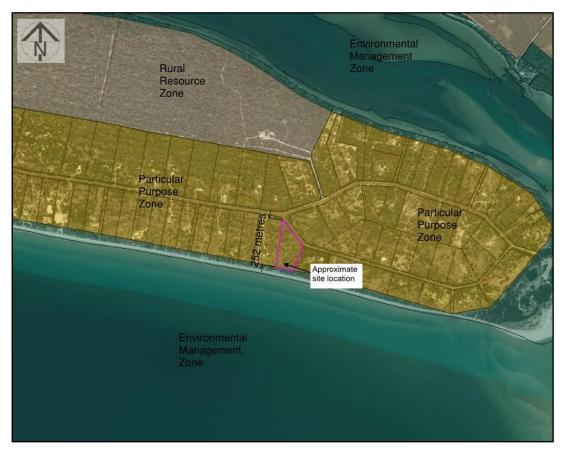
Figure 2. Shows the approximate location of the site (pink line) in the context of the adjacent lands and classified vegetation.

Vegetation surrounding the lot was assessed (Table 1) and described as 'Scrub' (as per AS3959-2018). The classified vegetation potentially having the greatest impact on the site occurs on every azimuth of the site (Figure 2). The vegetation classification system as defined in AS 3959-2018 Table 2.3 and Figure 2.3 (A to G) has been used to determine vegetation types within 100 metres of the site (Table 1).

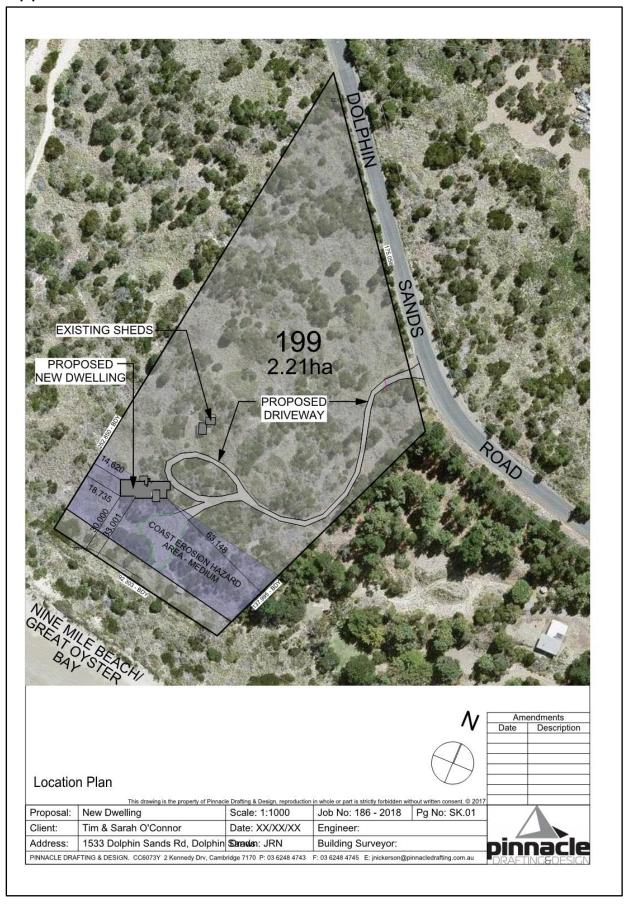
BUSHFIRE HAZARD MANAGEMENT PLAN

Bushfire Hazard Management Plan, 1533 Dolphin Sands Road Dolphin Sands. October 2019. GES05153v1.0 Glamorgan - Spring Bay Interim Planning Scheme 2015
