**GLAMORGAN SPRING BAY
COUNCIL**

ORDINARY COUNCIL MEETING – 19 JANUARY 2021

The Rookery Development

80 Burgess Street Bicheno

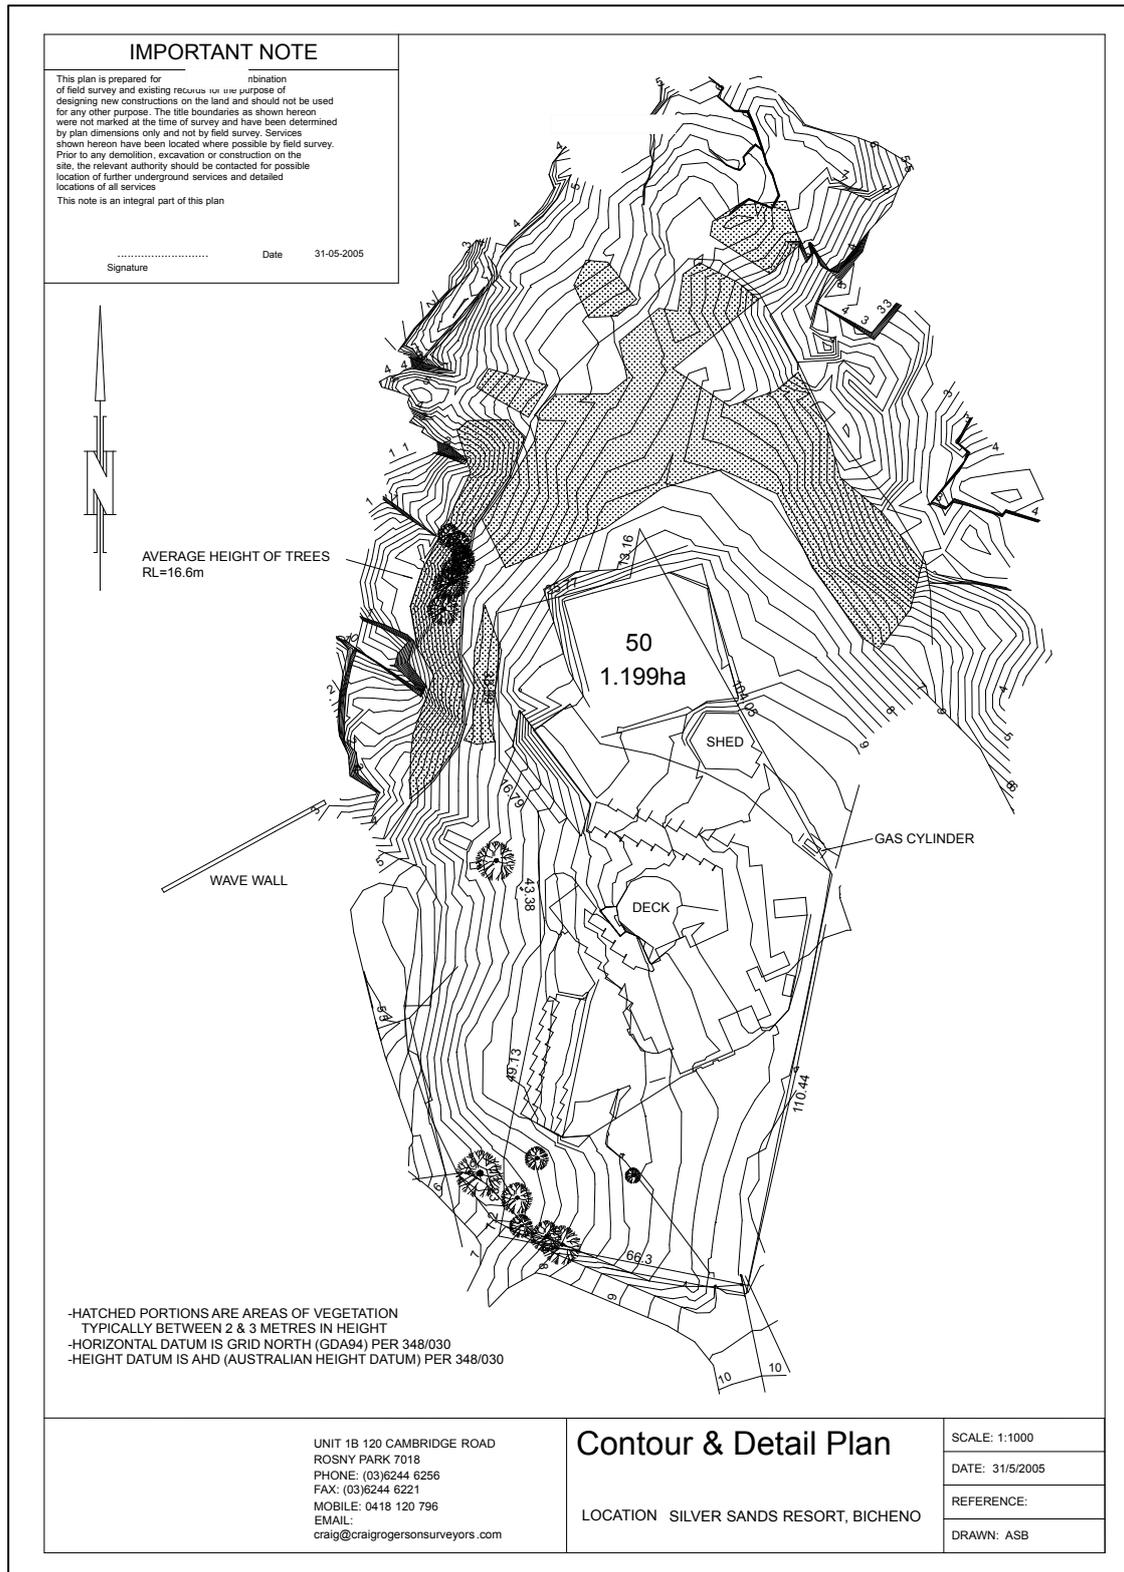
Figure 5: Contour and detail plan for the proposed Silver Sands Redevelopment study area.

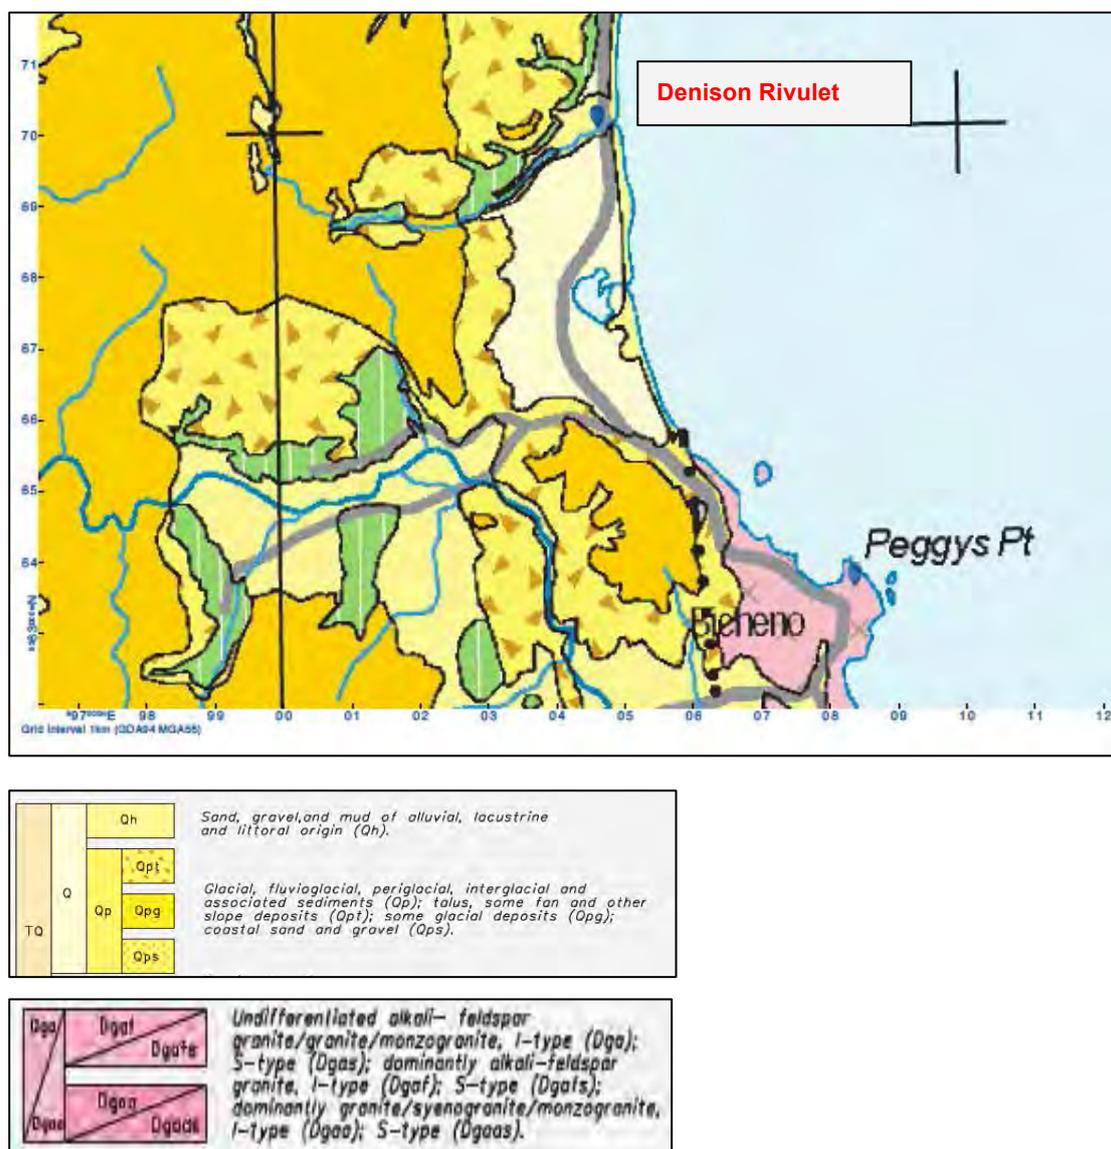
Figure 7: Geological mapping of the study areas, based on The LIST, theLIST (www.thelist.tas.gov.au) © State of Tasmania. Granite500 map, and the 1:25000 Geological Map of Tasmania (Calver et al 2014); Peggys Point marks the location of the Silver Sands Resort.

The two study areas lie on the coast that is highly exposed to eastern and southern swells, with average wave heights of one to one and a half metres (Short, 2006:79). The Denison Rivulet is usually blocked at its mouth on Denison Beach and there are generally 8 to 10 rips flowing across the bar here (Short, 2006:79). The beach continues to the south to the mouth of Old Mines Lagoon, which has similar geomorphological processes to the rivulet with a generally blocked mouth and 8 to 10 rips across the bar (Short, 2006:79). Further south of here, Denison Beach continues to Diamond Island, an active tombolo, which occasionally has an exposed shallow sand bar attached to the mainland (Short, 2006:79). Diamond Island is just north of the township of Bicheno and is a 5 ha nature reserve, well known for its penguin rookeries (Short, 2006:80). The tidal range on this section of coast is 1.3 metres (Short, 2006:79). Peggys Point is the most eastern of the three granite headlands south in Maclean Bay and is located within the township of Bicheno.

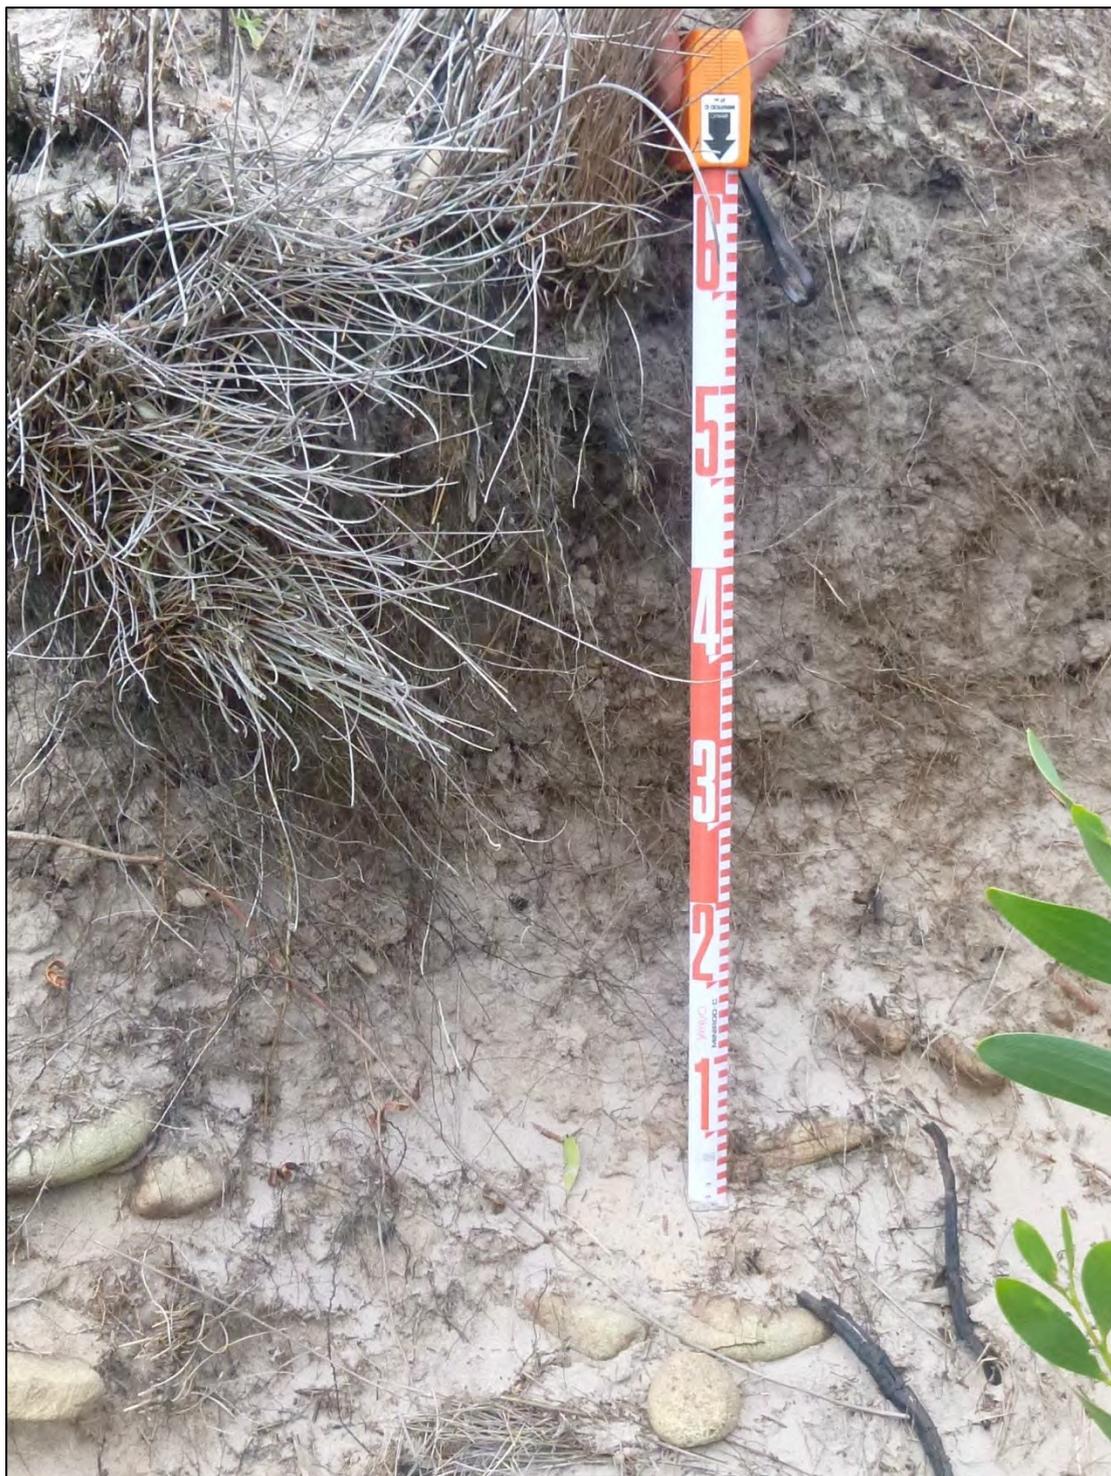
Plate 4: Section of stratigraphy seen on the eastern side of the rivulet, closest to where it flows to the beach. Note the river cobbles, at 60 cm in depth, typical of the local stratigraphy. Photo by Zvonka Stanin.

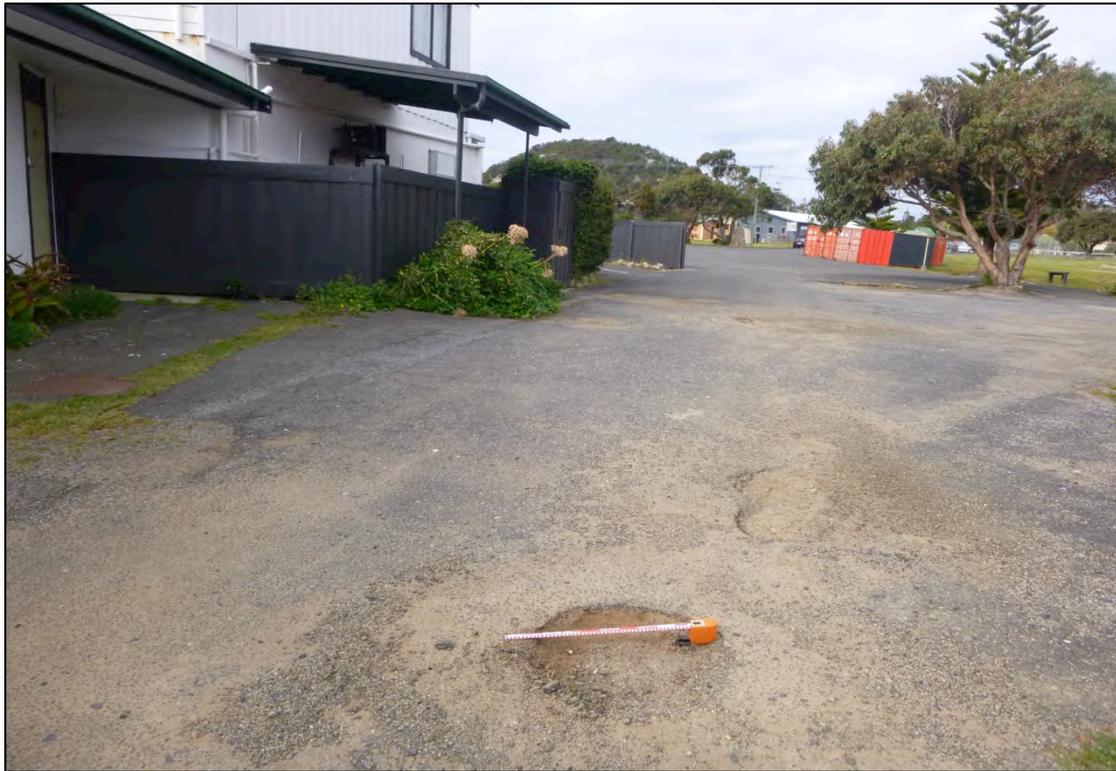
Plate 16: Cracks in the asphalt provide a very limited increase in visibility. However road base is generally deep. Photo by Z. Stanin.

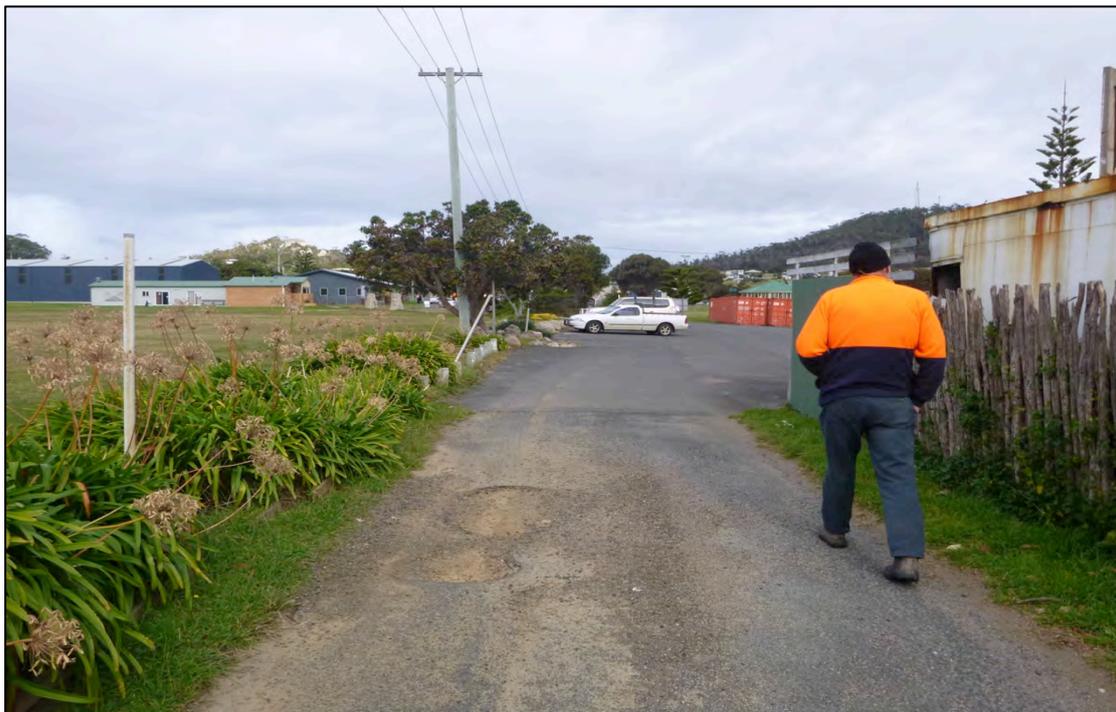
Plate 17: Cracks in the asphalt provide a very limited increase in visibility. However road base is generally deep. Photo by Z. Stanin.
